S E R V I C E N O T E

Agilent E5100A/B Network Analyzer

A broken AC inlet may potentially result in a electric shock hazard.

Duplicate Service Notes: E5100B-30-S

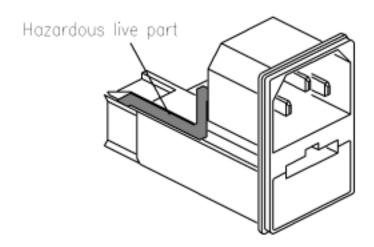
Figure 1. AC Inlet Connector

The AC inlet (P/N 1252-6951) has the potential to slip out of the instrument's rear panel slot if the AC power cord is forcefully pulled in a diagonal direction. When this happens, an exposed connection on the AC inlet module may touch the rear panel of the instrument and cause an electrical short if the AC power cord is still connected to the AC power outlet. See Figure 1.

In the worst case, there is also a possibility of an electric shock hazard to the user if the user completes a circuit between the instrument panel and another grounded connection while the AC power cord is still connected to the AC power outlet.

- Remove the AC power cable from the AC power outlet and the product.
- Remove the top, bottom, and side covers.
- Seal the hot line terminal on the AC inlet with silicon paste (P/N 5183-4112).
- Reinforce the connection between the AC inlet and the rear panel with silicon paste.
- Perform Self Test to verify instrument operation.
