# S E R V I C E N O T E

# Agilent E5100A/B Network Analyzer

A broken AC inlet may potentially result in a electric shock hazard.

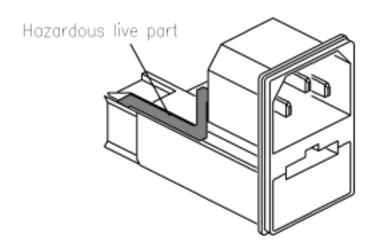
**Figure 1. AC Inlet Connector**

The AC inlet (P/N 1252-6951) has the potential to slip out of the instrument's rear panel slot if the AC power cord is forcefully pulled in a diagonal direction. When this happens, an exposed connection on the AC inlet module may touch the rear panel of the instrument and cause an electrical short if the AC power cord is still connected to the AC power outlet. See Figure 1.

In the worst case, there is also a possibility of an electric shock hazard to the user if the user completes a circuit between the instrument panel and another grounded connection while the AC power cord is still connected to the AC power outlet.

- Remove the AC power cable from the AC power outlet and the product.
- Remove the top, bottom, and side covers.
- Seal the hot line terminal on the AC inlet with silicon paste (P/N 5183-4112).
- Reinforce the connection between the AC inlet and the rear panel with silicon paste.
- Perform Self Test to verify instrument operation.

- Remove the AC power cable from the AC power outlet and the product.
- Remove the top, bottom, and side covers.
- Replace the rear panel assembly with P/N E5100-00223
- Install the new fuse P/N 2110-1303.
- Perform Self Test to verify instrument operation
