E5515C-11

S E R V I C E N O T E

E5515C Wireless Communications Test Set

Failure to power up due to an improperly inserted Power Supply connector.

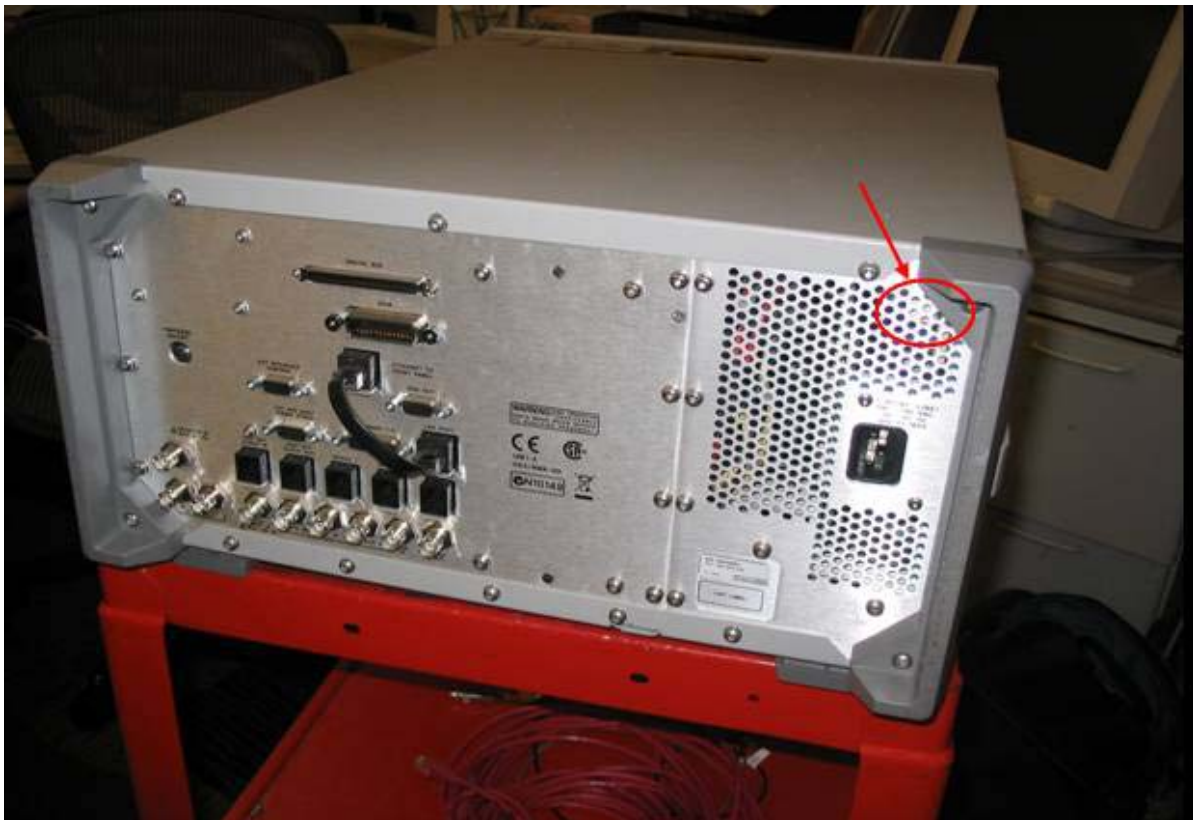
The power supply connector can be inspected externally through the rear-panel power supply vent holes (see Figure 2). There are two similar connectors -- the connector of interest is the top connector. A flash-light will be necessary to properly inspect the connector.

Figure 1 – Power Supply Vent holes and connector location

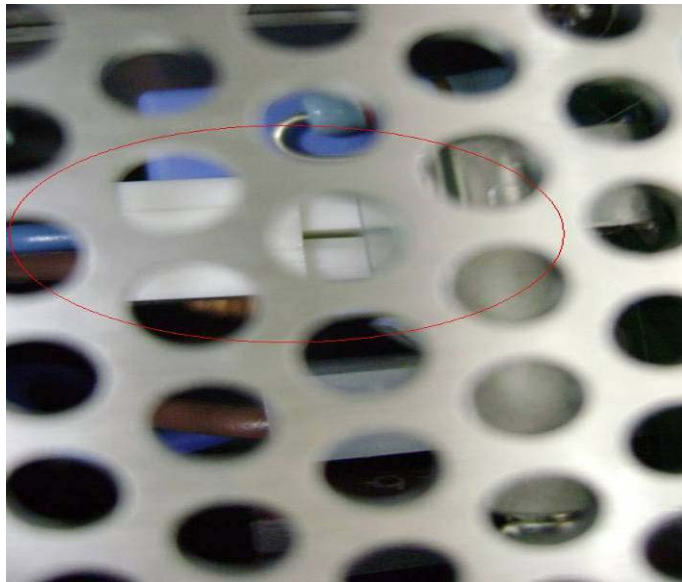
During the manufacturing process, a connector on the OEM power supply wasn't fully inserted to its locked position. A partially inserted connector can cause instrument operational failures. The symptoms can include both situations where the instrument will not power up or will unexpectedly power-down.

Figure 2 – close up of an improperly inserted power supply connector

If the connector is not fully inserted (see Figure 2), the connector can be pushed to its locked position by using an appropriate tool that will fit through a vent hole. A tool that works well is a "Beau-Tech" solder tool (SH-20B) or any similar tool (see Figure 3). If, in the unlikely event, the connector has separated completely from its mate, the instrument will have to be disassembled and the power supplies separated to access and re-insert the connector. As stated, this is very unlikely and has not been seen.

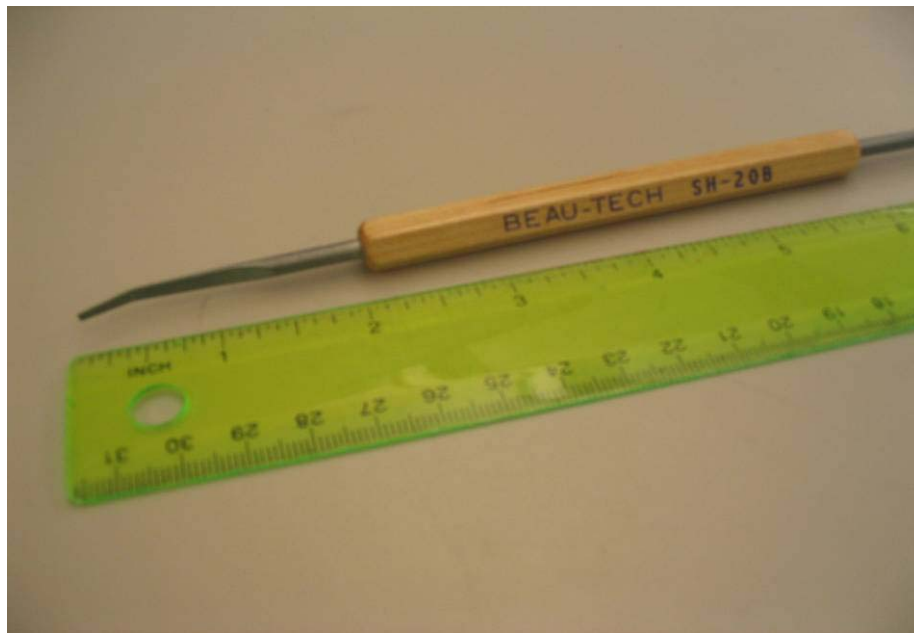
Figure 3 – generic tool to re-insert power supply connector
