E6393A-02

S E R V I C E N O T E

Agilent Technologies E6393A CDMA MS Test Set

The wrong jumper setting causes Printer Port failure

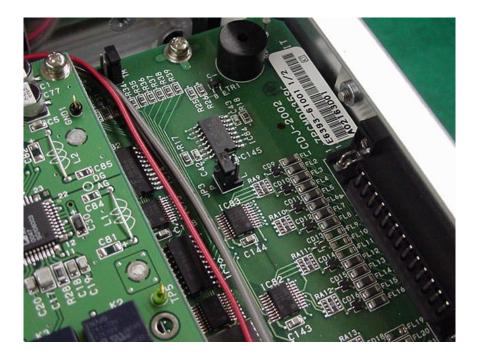
It has been found that some E6393A with the wrong jumper setting on A1 Management Processor Circuit was shipped. This wrong jumper setting causes the printer port failure. The printer port failures are as follows

- 1. Open the instrument cover referring to the Parts Replacement section of the E6393A Assembly Level Repair Manual.
- 2. Find the jumper "JP3" on the A1 Management Processor Circuit. It is located near the printer port connector, and between the IC83 and the IC84. See the picture below.

- 3. Check if the jumper is inserted to position "P". If it is inserted to position "L", move the jumper to position "P".
- 4. Check the E6393A can print out to the printer.
- 5. Replace the instrument cover.
