S E R V I C E N O T E

E4401B, E4402B, E4403B, E4404B, E4405B, E4407B, E4408B, and E4411B ESA Spectrum Analyzer family. Also E7401A, E7402A, E7403A, E7404A, and E7405A EMC Pre-Compliance Analyzers.

Intermittent screen "flicker" due to a cold solder joint

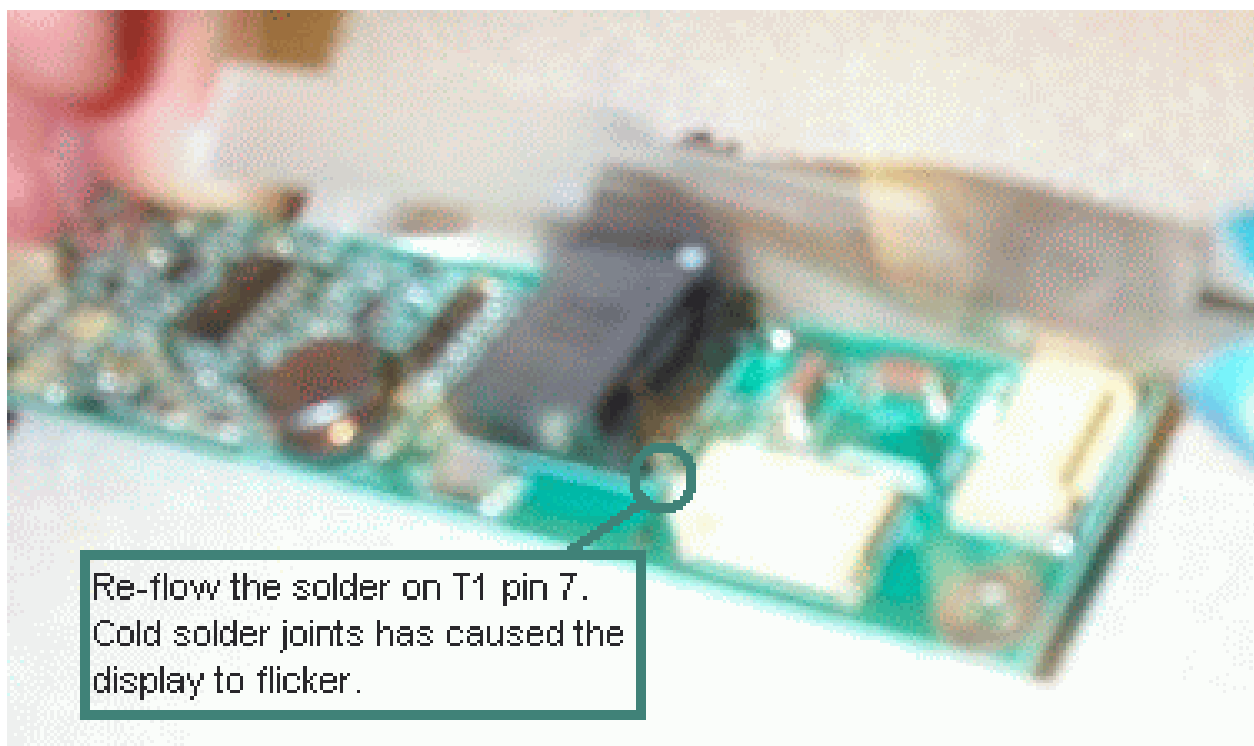
Figure 3

Instruments within the above serial range can experience an intermittent screen "flicker" due to a cold solder joint on pin 7 of the transformer on the backlight inverter board. The backlight inverter board attaches to the front panel interface board (A1A1) on the analyzer. The attached figures below in the Solution/Action section can be referenced on the procedure to use to correct for this problem.

3) Re-solder pin 7 of the transformer on the backlight inverter board. See Figure 3.
