E7912A-01-S

<u>SERVICE NOTE</u>

N2X (Router Tester 900) Chassis

Potential power supply failure due to component lead length.

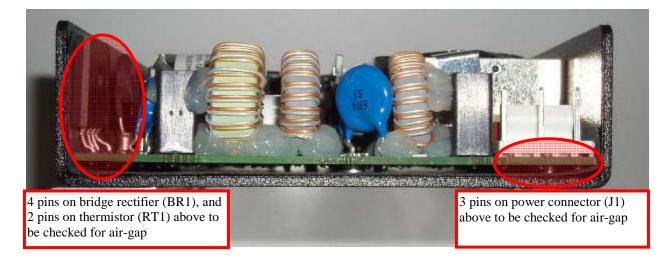
Analysis showed that some through-hole components did not have their leads trimmed to the proper length (they were too long), and as a result of vibration testing done after OEM HiPot tests, or shock/vibration in transit, the extended leads were piercing the insulation barrier between the mains powered components, and the PSU metalwork.

Check the power supply through-hole components as shown below to ensure that there is an air gap between the component leads highlighted and the insulation situated between the metalwork and PCB.

If there is an air-gap, the power supply can be re-fitted to the chassis and returned to the customer after being tested in accordance with the procedures outlined in the above mentioned service manual.

If there is *not* an air gap, then the power supply should be replaced by a new one – part number E7900-64800 – and the defective one should be returned to SPO for credit return to the division manufacturing organisation.
