E8257D-36

Information Only Service Note

E8257D Analog Signal Generator

Communication Failure when using GPIB to download firmware with Firmware Upgrade Assistant (FUA).

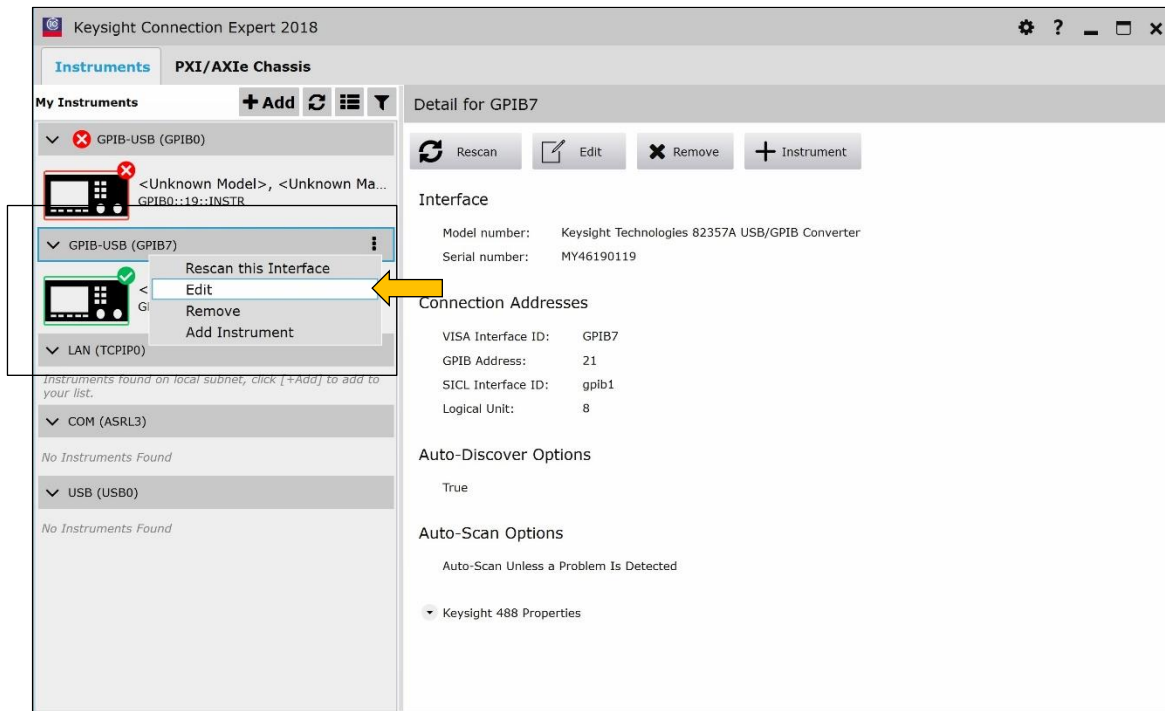
Figure 1

You may encounter GPIB communication failure when using the Firmware Upgrade Assistant (FUA) to upgrade your instrument. This is due to the IO Libraries that disabled the GPIB card.

1. On your PC, start the Keysight Connection Expert software. Click Start > All Programs > Keysight IO Libraries Suite > Agilent Connection Expert. If you do not have Keysight IO Libraries Suite installed on your PC, you can download it from the following website: <http://www.keysight.com/find/iolib>.
2. In the Instruments tab, select your instrument to make the connection.
3. Right-click on “GPIB-USB (GPIB#)” # represents the Visa Interface ID #. Then, click “Edit”. (Refer to Figure 1)

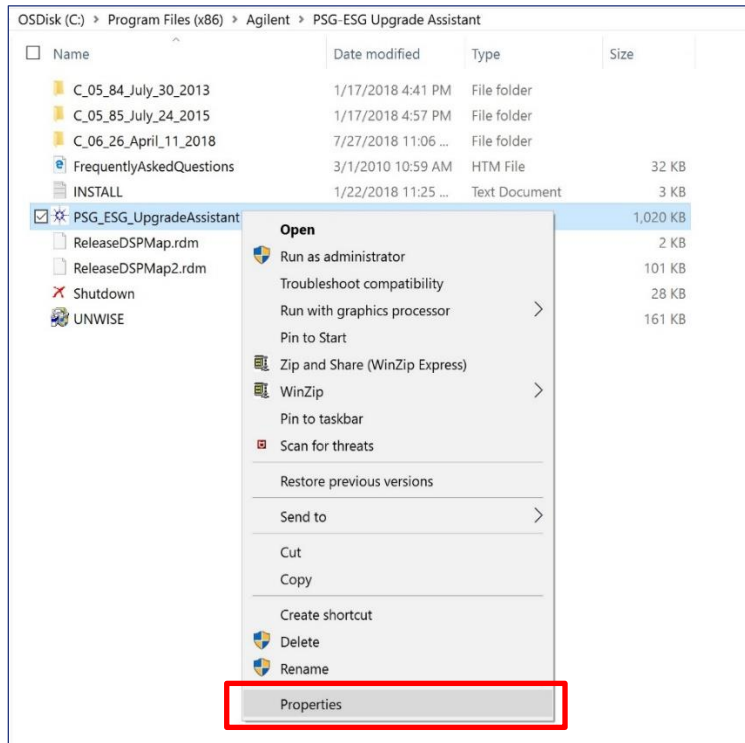
Figure 3

Below are also some extra settings if you are using Windows10 and unable to run the FUA.

1. Find the PSG-ESG Upgrade Assistant application file in the C drive. By default, it is installed on C:\Program Files(X86)\Agilent\PSG-ESG Upgrade Assistant folder. Right click on it.
2. Then click on “Properties”. (Refer to Figure 3)
