# E8356A-02E

# S E R V I C E N O T E

## E8356A PNA Series RF Network Analyzers

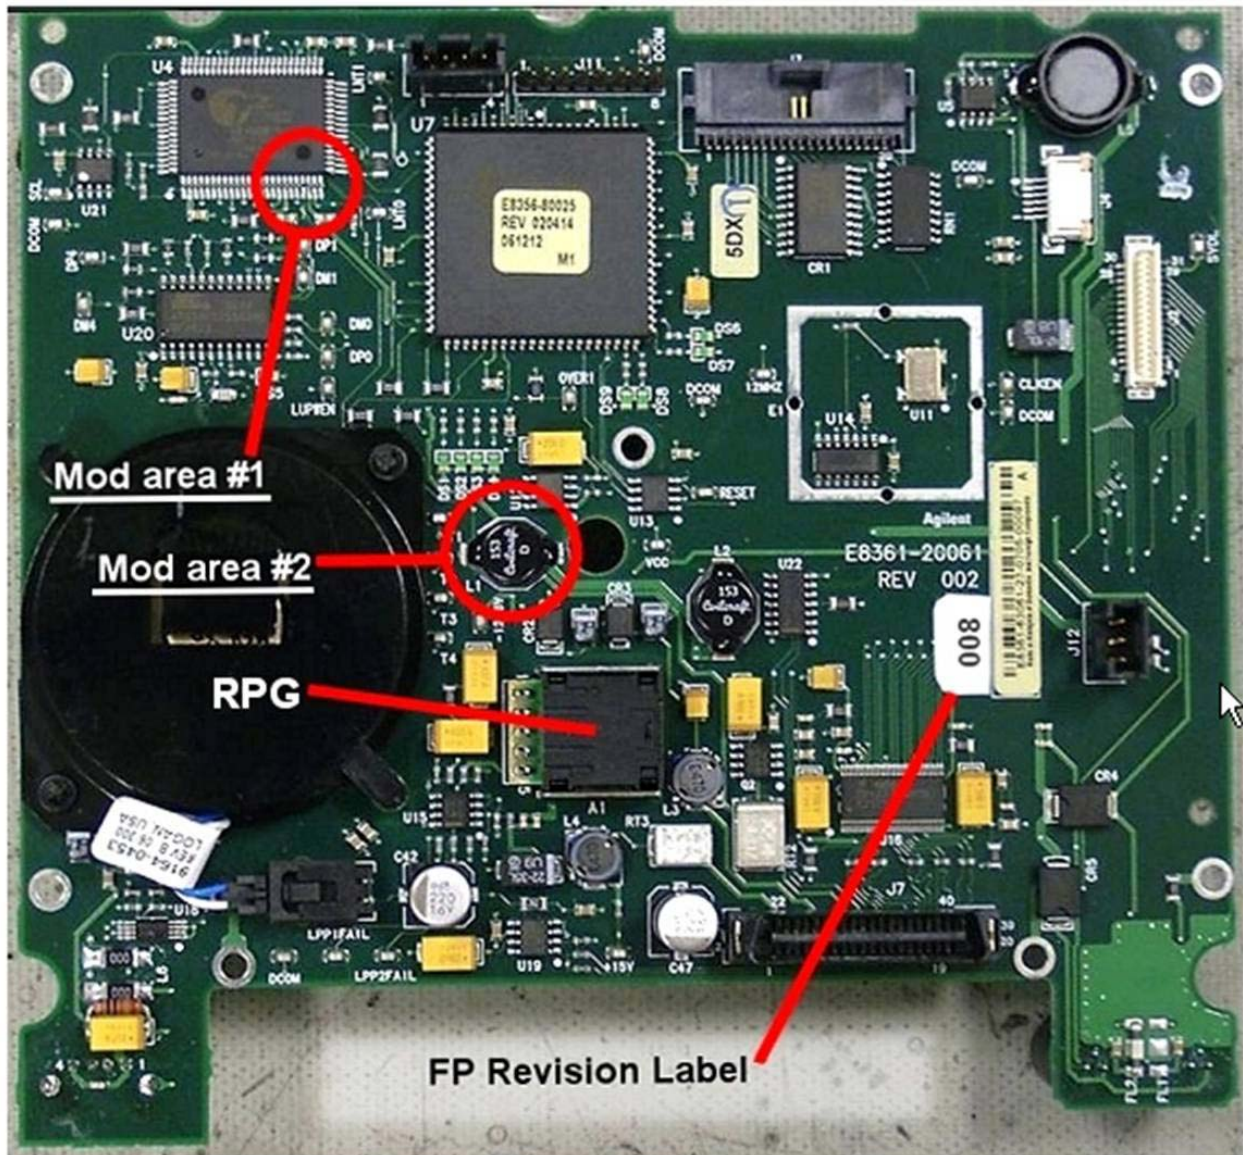
Refer to Figure 1 for the two modification areas to be addressed. Note that while this picture happens to show the FPI board completely removed from the front frame assembly, this is not necessary to perform the required modifications.

- Modification #1 consists of shorting two pins of U4 together with a small amount of solder.
- Modification #2 consist of removing L1.

Unsolder and completely remove the black surface mount inductor L1 from the front panel assembly board. This is no longer needed and can be discarded.

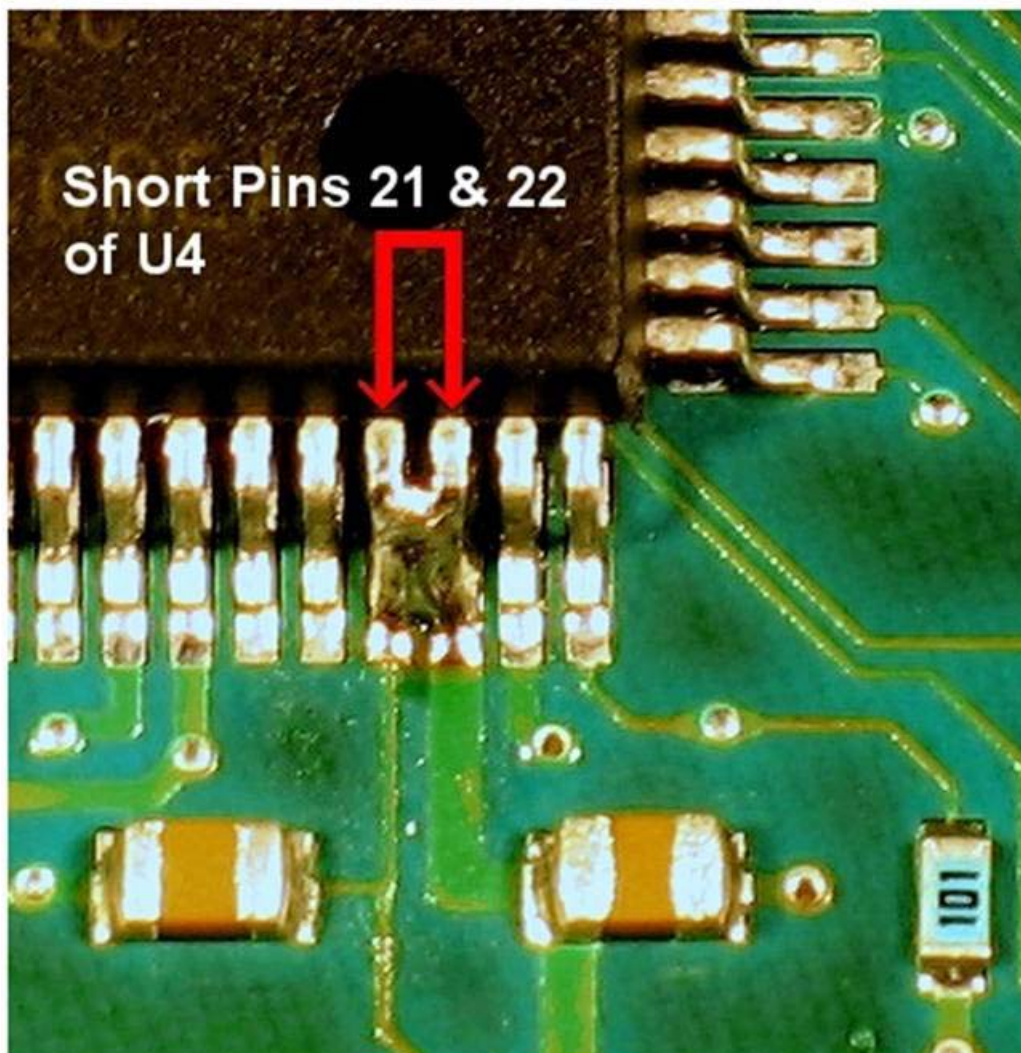
**Figure 2**

Both intermittent problems have been traced to an incorrect voltage applied to a pin on the U4 IC.

Carefully solder pins 21 and 22 together on U4. Refer to Figure 2 for the exact location. Use care so that no other pins are shorted. Use of a very fine tip soldering iron is recommended and a large work-task magnifying glass is very helpful.
