E8357A-06A

SERVICE NOTE

E8357A PNA Series RF Network Analyzers

Replace Inverter board (0950-3379) due to faulty component.

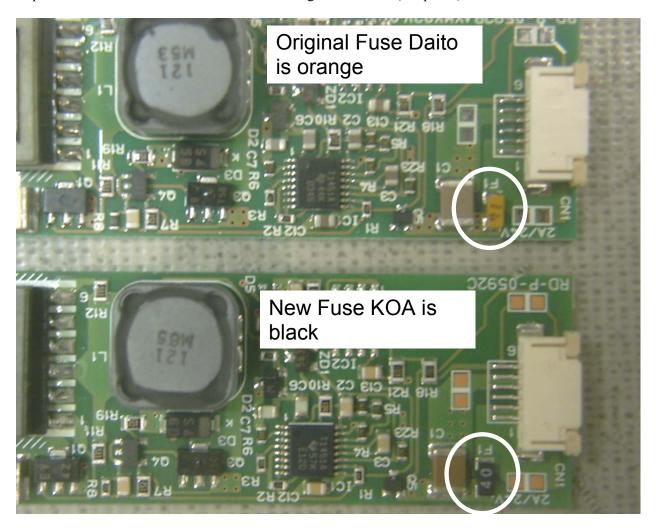
The original fuse (see photo) in the DC/AC Inverter board (p/n 0950-3379) is prone to failure in normal use.

Replace the Inverter board with a board containing the new fuse (see photo).
