# E8358A-02F

# S E R V I C E N O T E

## E8358A PNA Series RF Network Analyzers

Serial Numbers: 00000000 thru 46999999

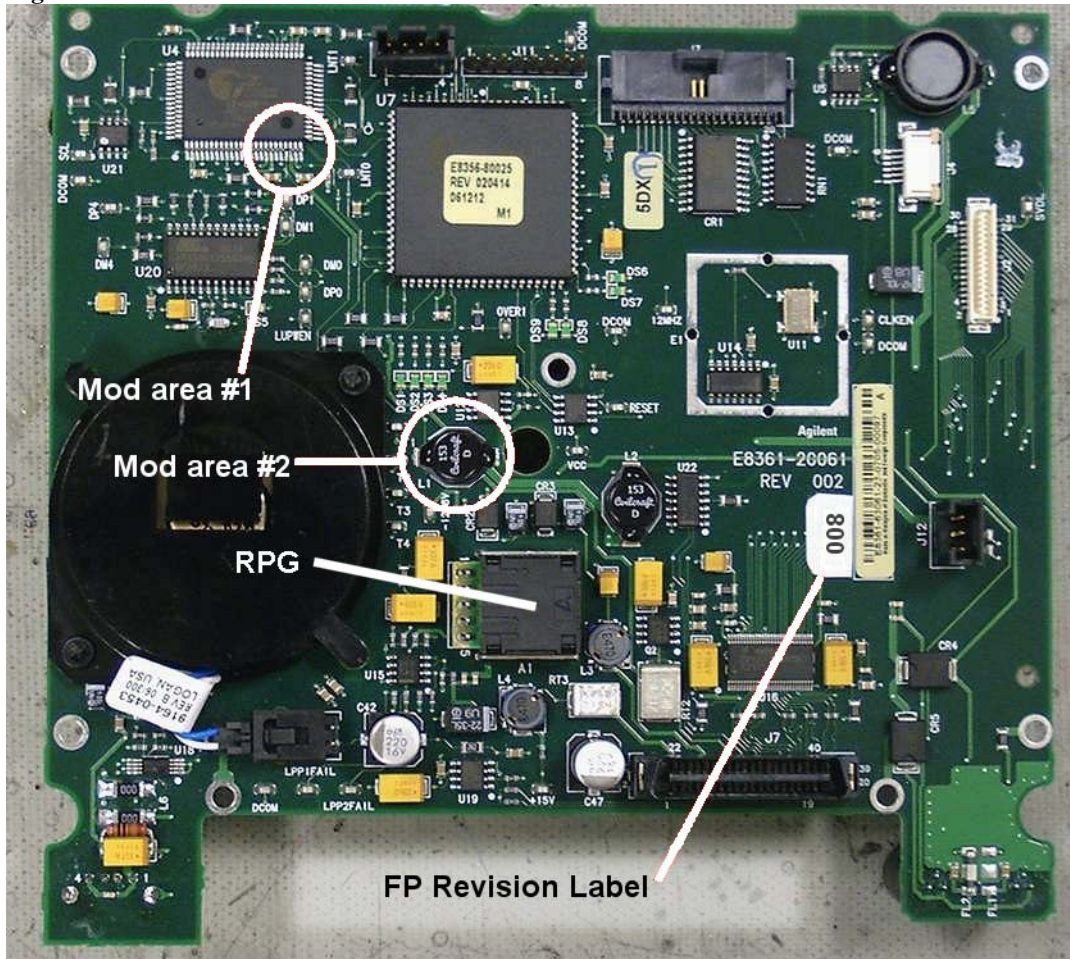
Both intermittent problems have been traced to an incorrect voltage applied to a pin on the U4 IC.

Refer to Figure 1 for the two modification areas to be addressed. Note that while this picture happens to show the FPI board completely removed from the front frame assembly, this is not necessary to perform the required modifications.

- Modification #1 consists of shorting two pins of U4 together with a small amount of solder.
- Modification #2 consist of removing L1.

Unsolder and completely remove the black surface mount inductor L1 from the front panel assembly board. This is no longer needed and can be discarded.
