E8362A-05A

S E R V I C E N O T E

E8362A PNA Series RF Network Analyzers

Replace Inverter board (0950-3379) due to faulty component.

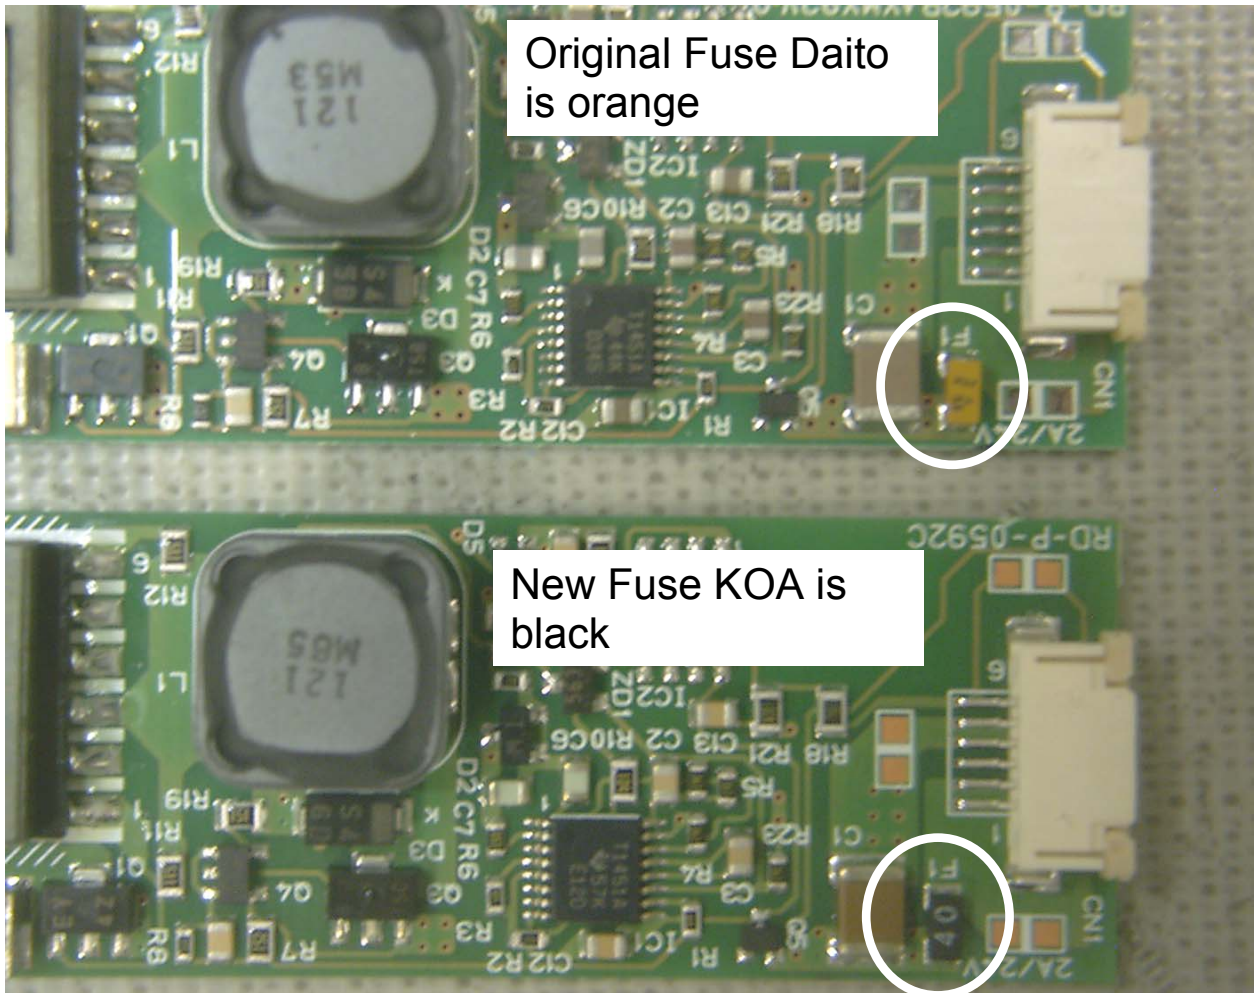
The original fuse (see photo) in the DC/AC Inverter board (p/n 0950-3379) is prone to failure in normal use.

Replace the Inverter board with a board containing the new fuse (see photo).
