## E8363B-06A

# SERVICE NOTE

## E8363B PNA Series RF Network Analyzers

Replace Inverter board (0950-3379) due to faulty component.

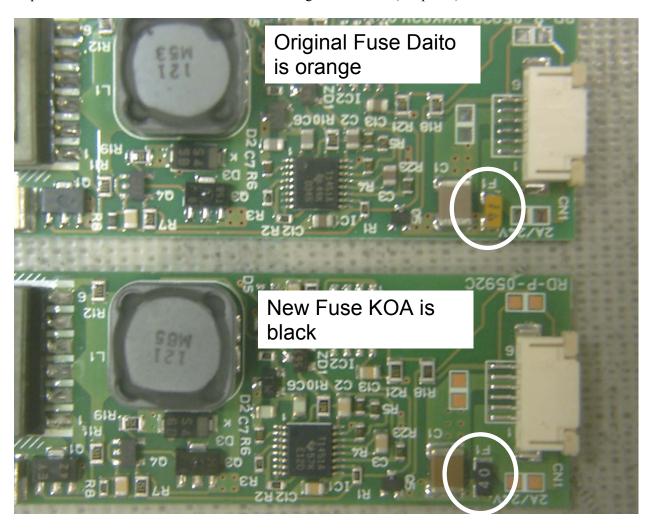
The original fuse (see photo) in the DC/AC Inverter board (p/n 0950-3379) is prone to failure in normal use.

Replace the Inverter board with a board containing the new fuse (see photo).
