E8364A-06A

SERVICE NOTE

E8364A PNA Series RF Network Analyzers

Replace Inverter board (0950-3379) due to faulty component.

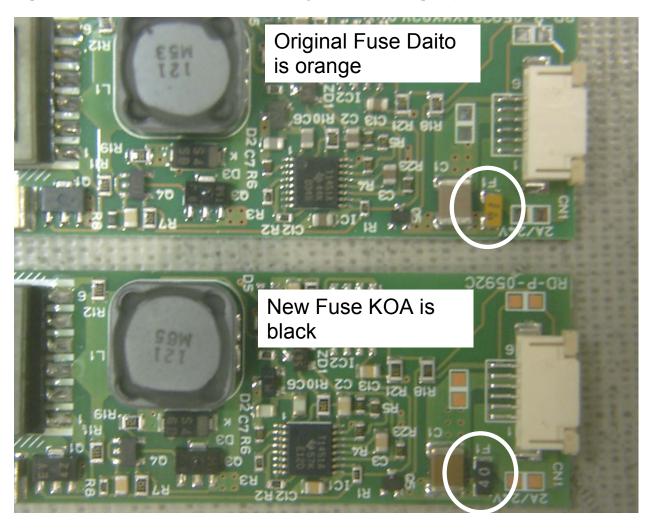
The original fuse (see photo) in the DC/AC Inverter board (p/n 0950-3379) is prone to failure in normal use.

Replace the Inverter board with a board containing the new fuse (see photo).
