E8801A-05A

S E R V I C E N O T E

E8801A PNA Series RF Network Analyzers

Replace Inverter board (0950-3379) due to faulty component.

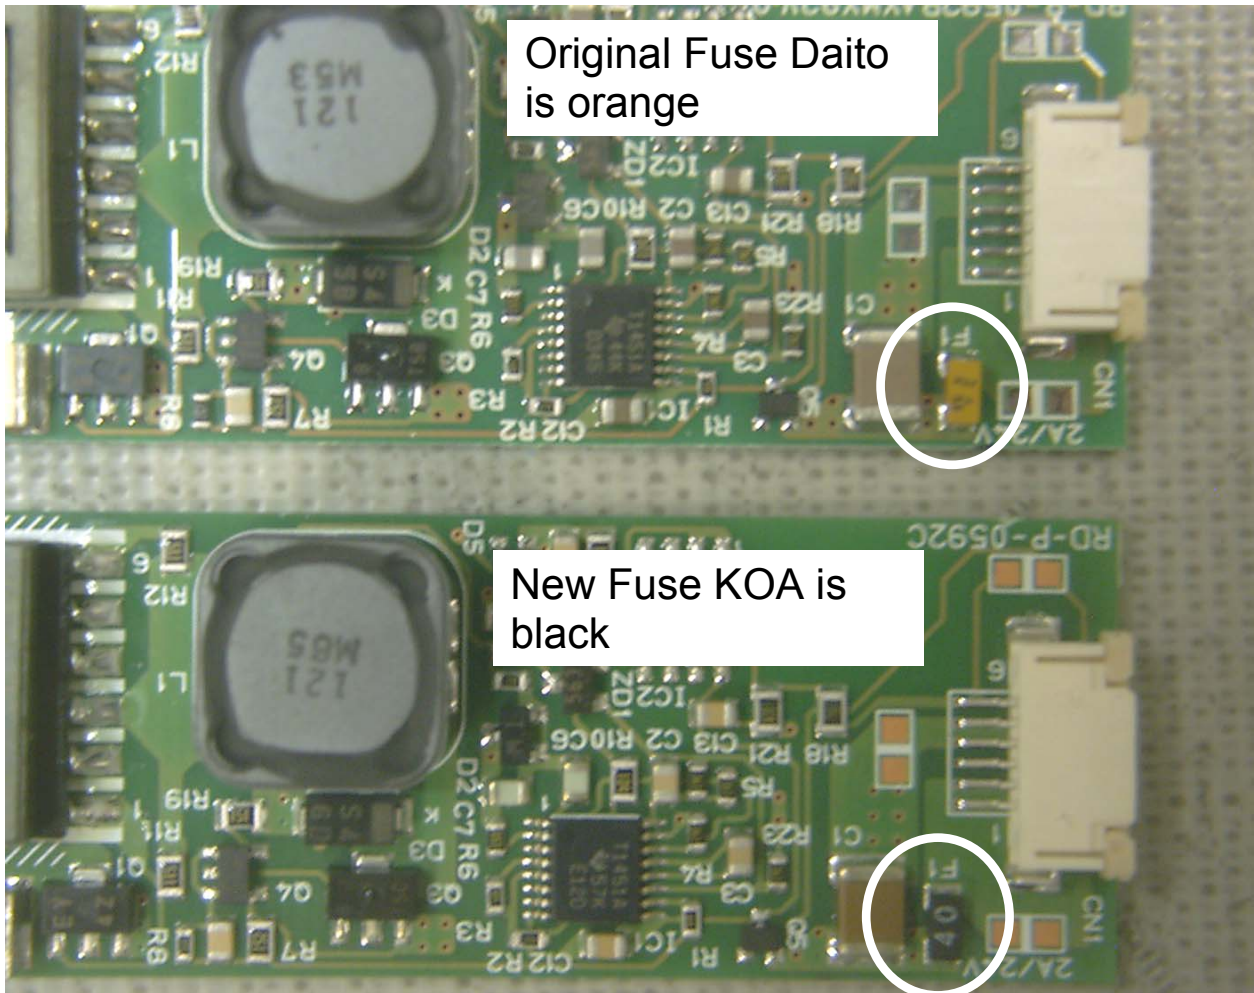
The original fuse (see photo) in the DC/AC Inverter board (p/n 0950-3379) is prone to failure in normal use.

Replace the Inverter board with a board containing the new fuse (see photo).
