E8802A-05A

SERVICE NOTE

E8802A PNA Series RF Network Analyzers

Replace Inverter board (0950-3379) due to faulty component.

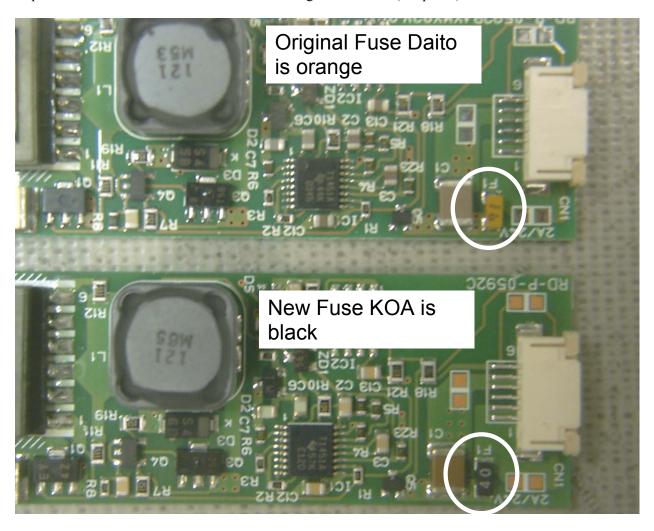
The original fuse (see photo) in the DC/AC Inverter board (p/n 0950-3379) is prone to failure in normal use.

Replace the Inverter board with a board containing the new fuse (see photo).
