E8803A-05A

SERVICE NOTE

E8803A PNA Series RF Network Analyzers

Replace Inverter board (0950-3379) due to faulty component.

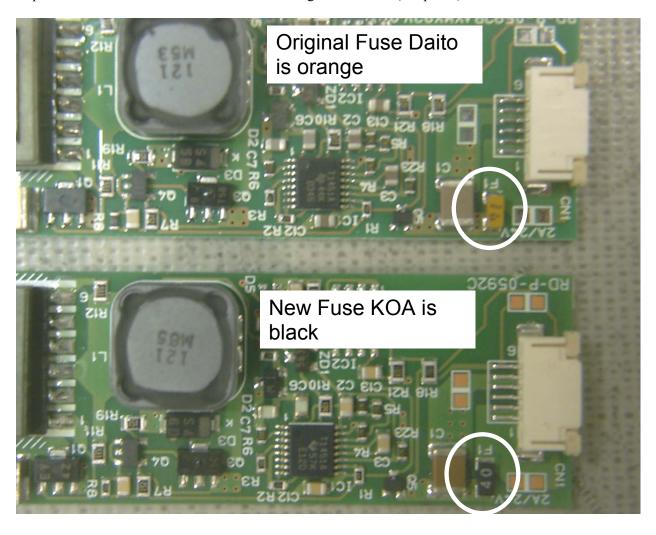
The original fuse (see photo) in the DC/AC Inverter board (p/n 0950-3379) is prone to failure in normal use.

Replace the Inverter board with a board containing the new fuse (see photo).
