SN J4630A-01

J4630A VQT Undercradle

Updated replacement of analog card for improved PESQ scores

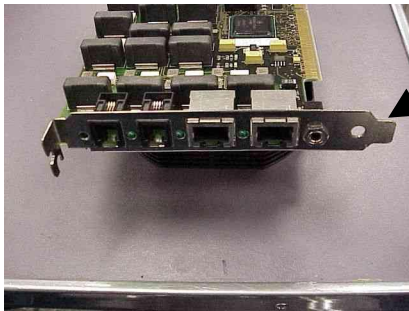
Move metal tab to
new assembly.

Replace the analog FXO E&M card with the latest version. This, along with downloading the VQT application Software Version 4.1.1 or later. When the “defective” analog card is removed the metal grounding tab MUST be swapped to the new assembly.
