SN J6800A-07

S E R V I C E N O T E

J6800A Network Analyzer

February 23, 2006

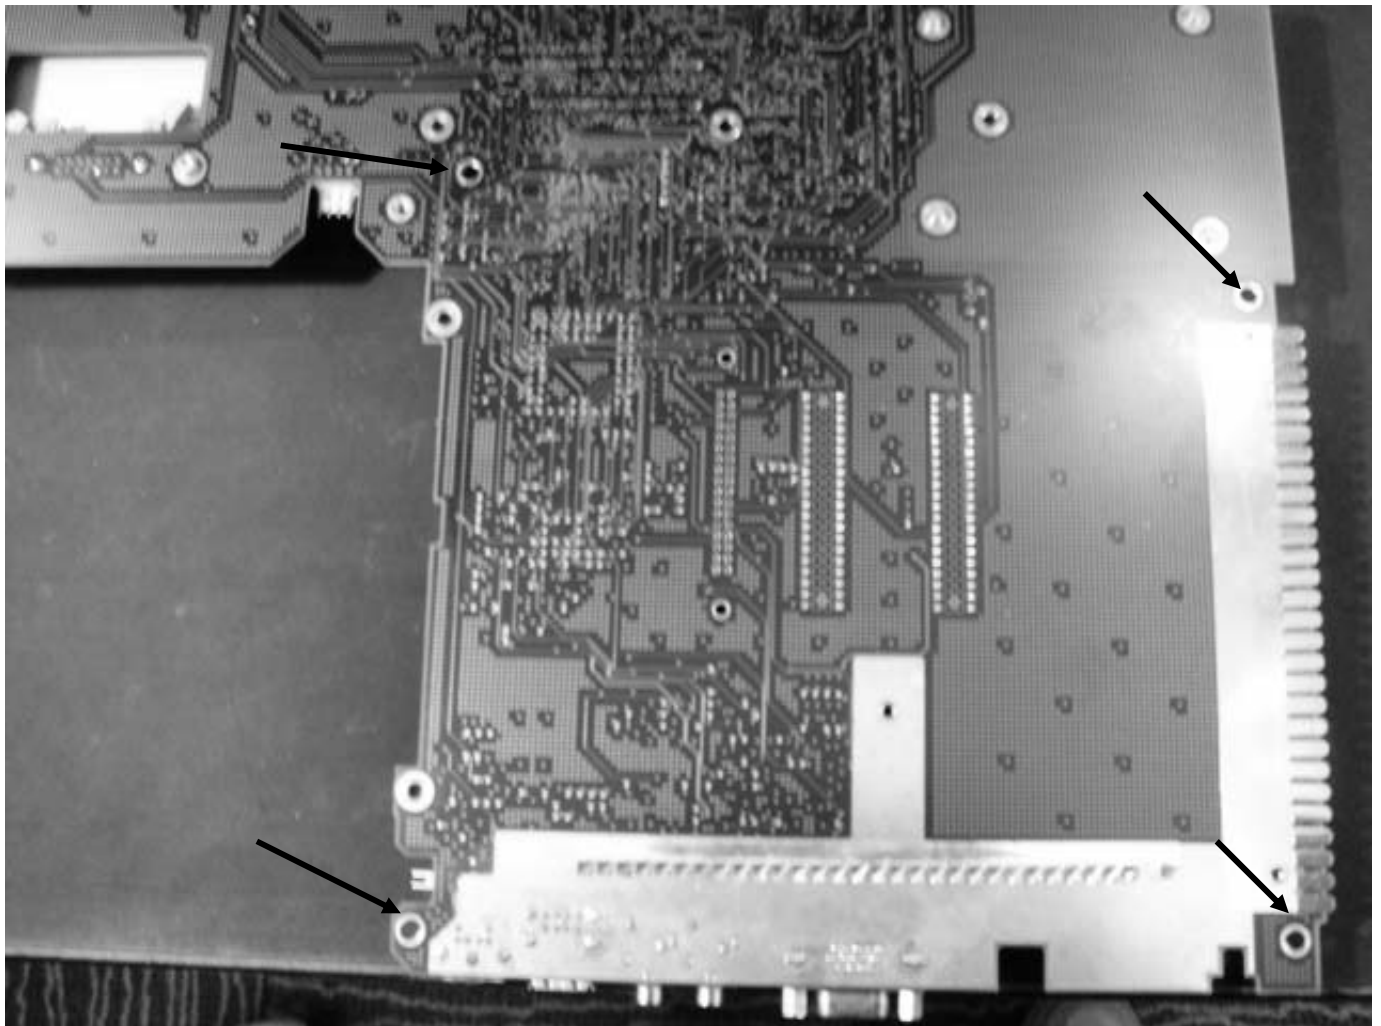
The CPU carrier card has 4 mounting holes that are used to hold the acquisition cards to the chassis. (See photo #1) After some extended period of time, the threads on these screws cuts through the plating of the hole and wears away the PCB material, exposing the copper inner-layers. (See photo #2) These exposed copper layers can short 3.3v or 5.0v to ground. This causes excessive current draw, stressing the power supply and often scorching the Host I/O power connector itself. (See photo #3)

Replace all damaged parts, re-assemble unit using the washers(3050-2187) and test per J6800A service manual.

Use washers (3050-2187) with long mounting screws when re-assembling.

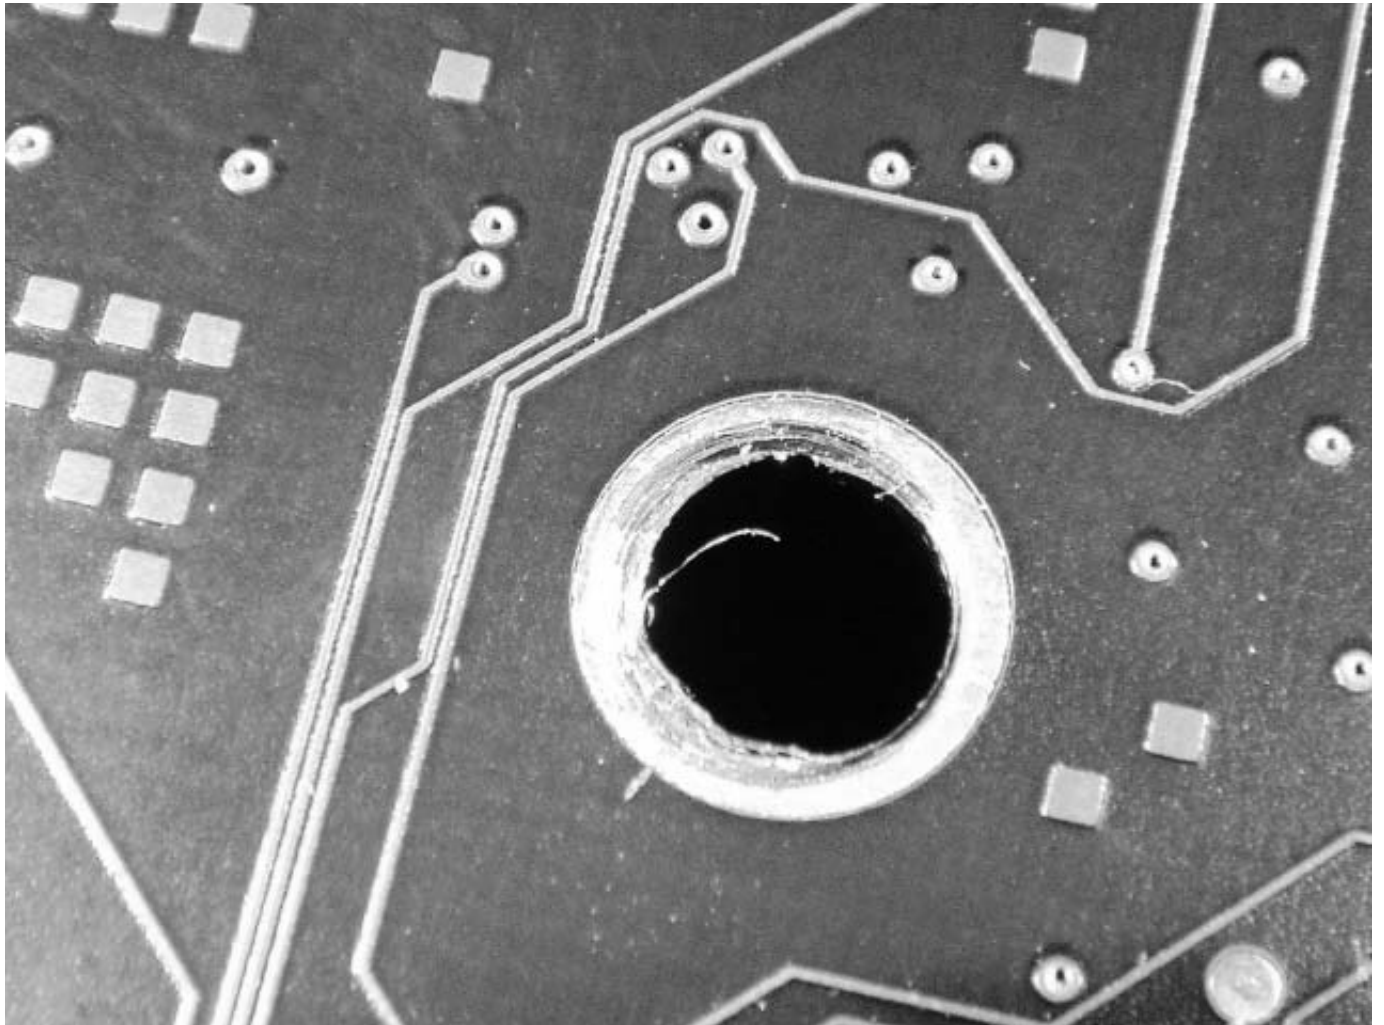
Photo #2 Close up of mounting hole showing copper pulled down into hole.
