J6803B-01

S E R V I C E N O T E

J6803B Agilent DNA Pro

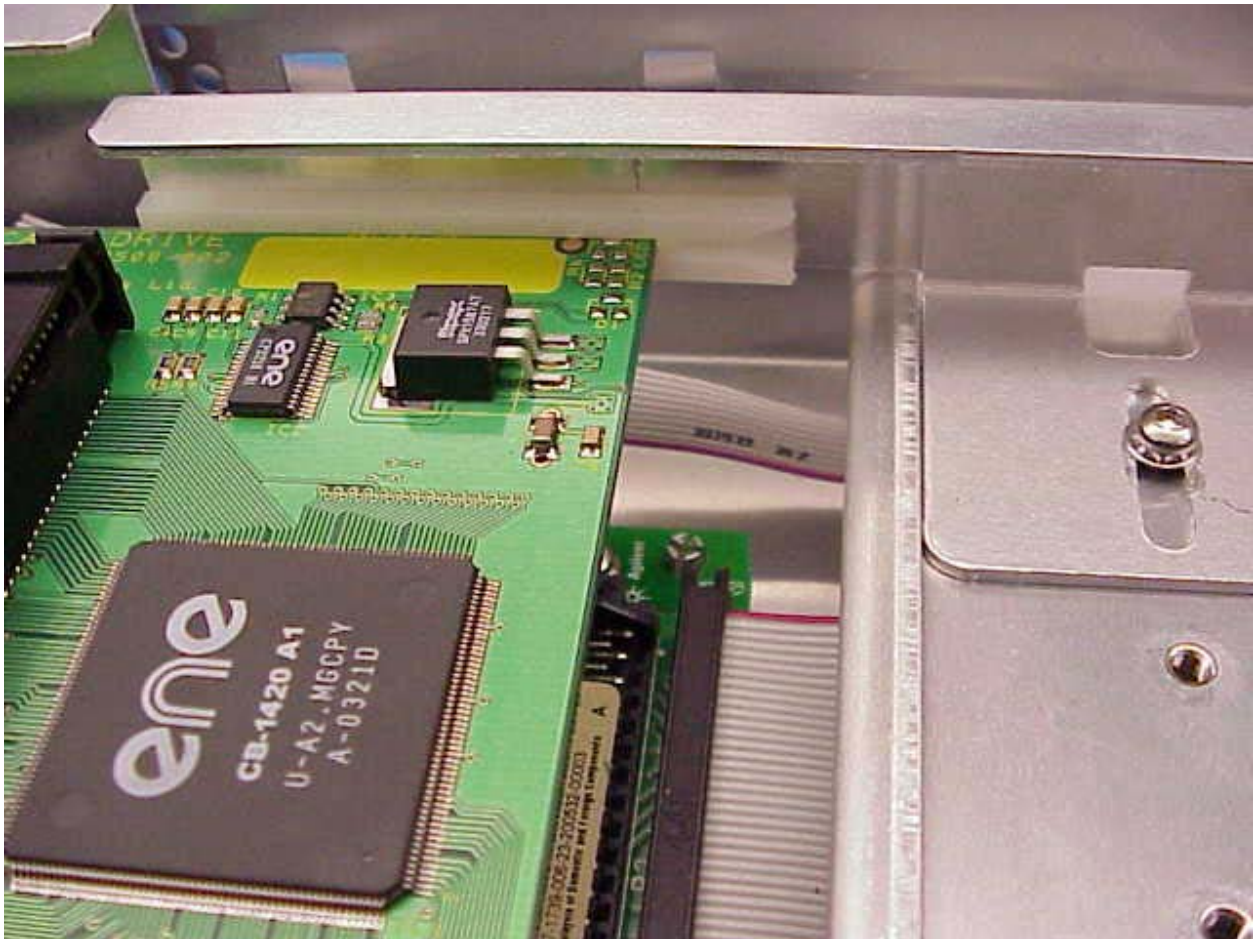
If the J6803A Network Interface Card (NIC) is not properly re-assembled into the hold-down bracket, it can become unseated and cause network connectivity to be lost.

There is a groove in the plastic insulator of the hold-down bracket. The edge of the NIC card must be inserted **into** this groove and the bracket then screwed down. (See picture)
