M1740A-02

Modification Recommended Service Note

M1740A - mmWave Transceiver for 5G

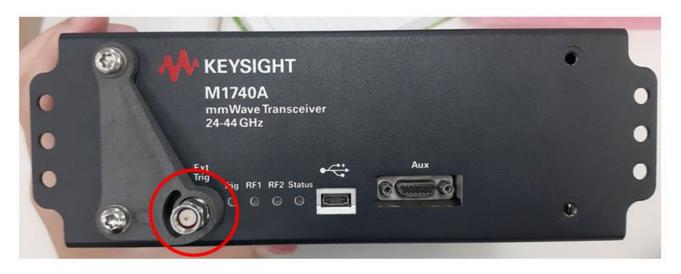
Problem = External Trigger cable connected to the M1740A external trigger connection puts stress on the center pin and breaks.

Add the M1740-20034 RF support bracket to hold the External trigger cable and prevent the stress on the External trigger connector center pin. Prevent breakage.

Add the following parts to the side of the M1740A when returned to service center for calibration and/or repair.
