M3302A-01

Modification Recommended Service Note

M3302A PXIe AWG and Digitizer Combination

The Problem – D.C offset error on the AWG output due to:

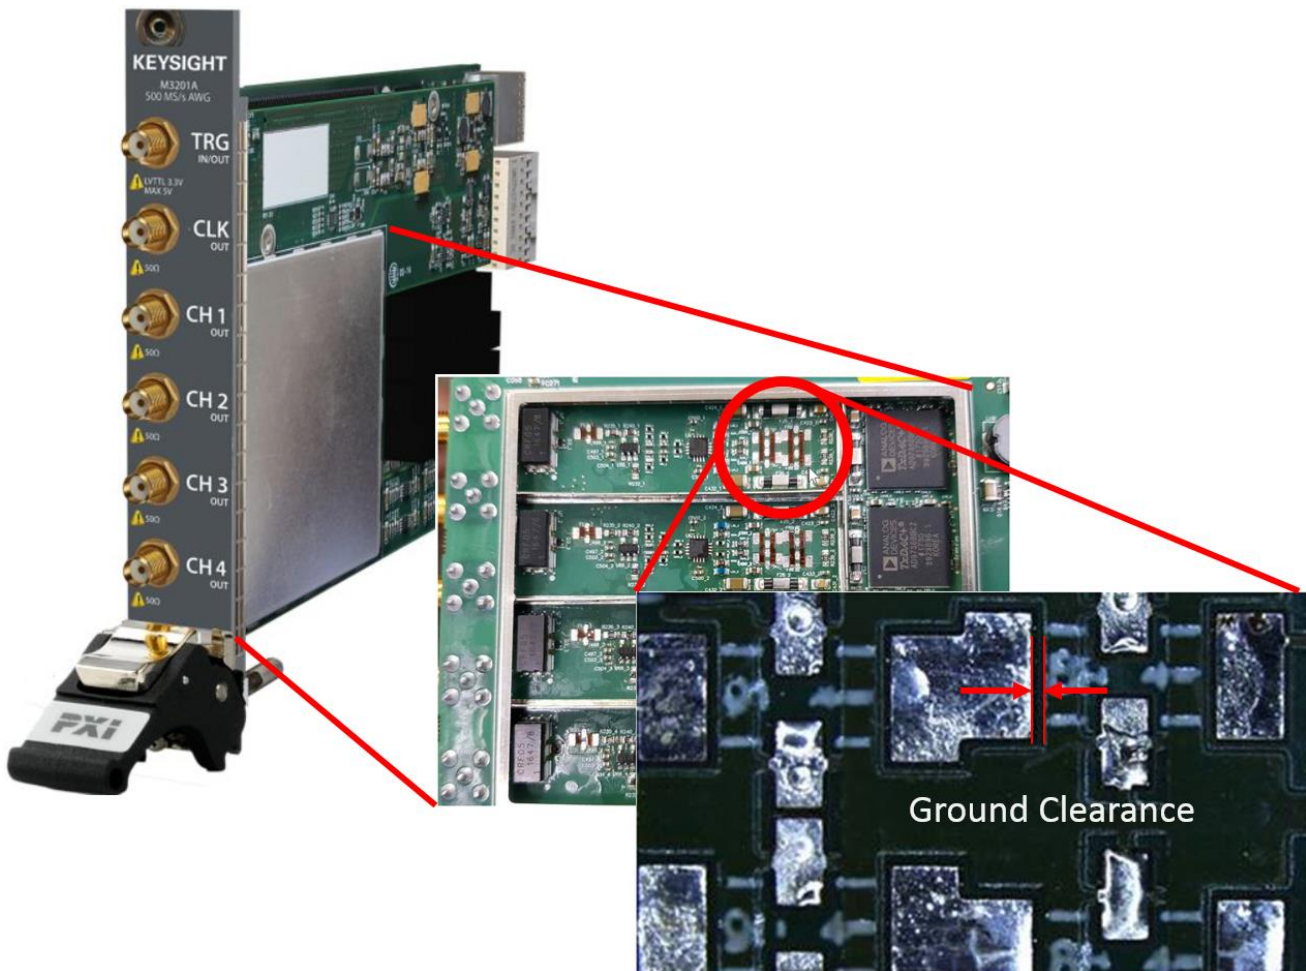
1. A possible short circuit between the filter output pad and the PCB ground plane due to insufficient ground clearance in the PCB design.
1. The performance of the filter changed sometime in 2017 which was not picked up by Keysight. This resulted in unstable DC offset performance after being in operation for some time.

The ground plane clearance problem can be seen below:

These problems have been fixed in all modules, M3201A & M3202A, M3300A & M3302A from MY57510001 onwards.

PXIe AWG M3201A & M3202A and PXIe AWG and Digitizer Combo M3300A & M3302A exhibiting excessive DC offset can be returned to keysight for repair and full calibration.
