M9010A-04

Information Only Service Note

M9010A PXIe Chassis: 10-slot, 3U, 24 GB/s, Gen 3

System not being able to enumerate PXI modules due to code 10 errors under Device Manager for PCI Express to PCI/PCI-X Bridge when use with M9025A.

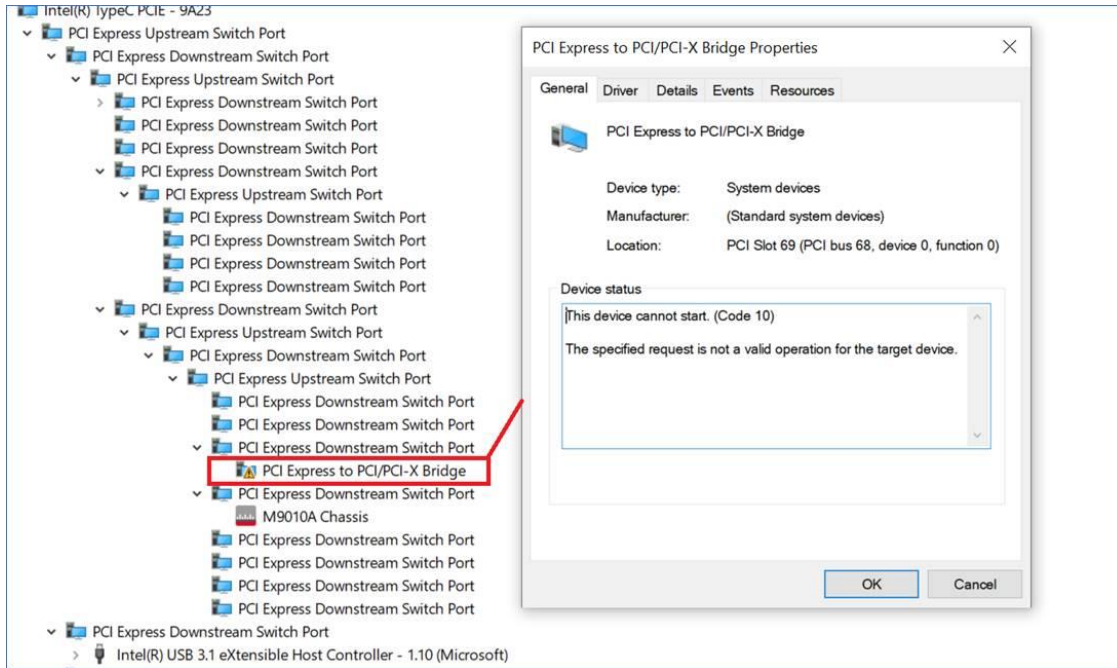
It has been found when the affected chassis are used with M9025A PXIe Thunderbolt System Module that the Device Manager would encounter code 10 errors under the PCI Express to PCI/PCI-X Bridge like picture below. This results in the system not being able to enumerate PXI modules in the chassis.

If you run into code 10 errors under Device Manager for PCI Express to PCI/PCI-X Bridge when used with M9025A in non-affected Keysight PXIe Chassis from table above, follow the steps below to resolve the code 10 errors at the PCI Express to PCI/PCI-X Bridges.

1. Install drivers version 1.7.1032.1 or later at the chassis product website <http://www.keysight.com/find/M9010A>, navigate to Technical Support > Drivers, Firmware and Software > PXIe Chassis Family Drivers.
2. After updating the drivers, run the update FW tool at the chassis product website <http://www.keysight.com/find/M9010A>, navigate to Technical Support > Drivers, Firmware and Software > Chassis Firmware.
 - a. When the *.bin file is run, it will detect the PXI-X switch Firmware needing to be updated like picture below. Press Update to update.
