MSO9104A-08

# Information Only Service Note

## MSO9104A – Infiniium DSO, 1GHz, 10/20 GSa/s, 4Ch + 16Ch

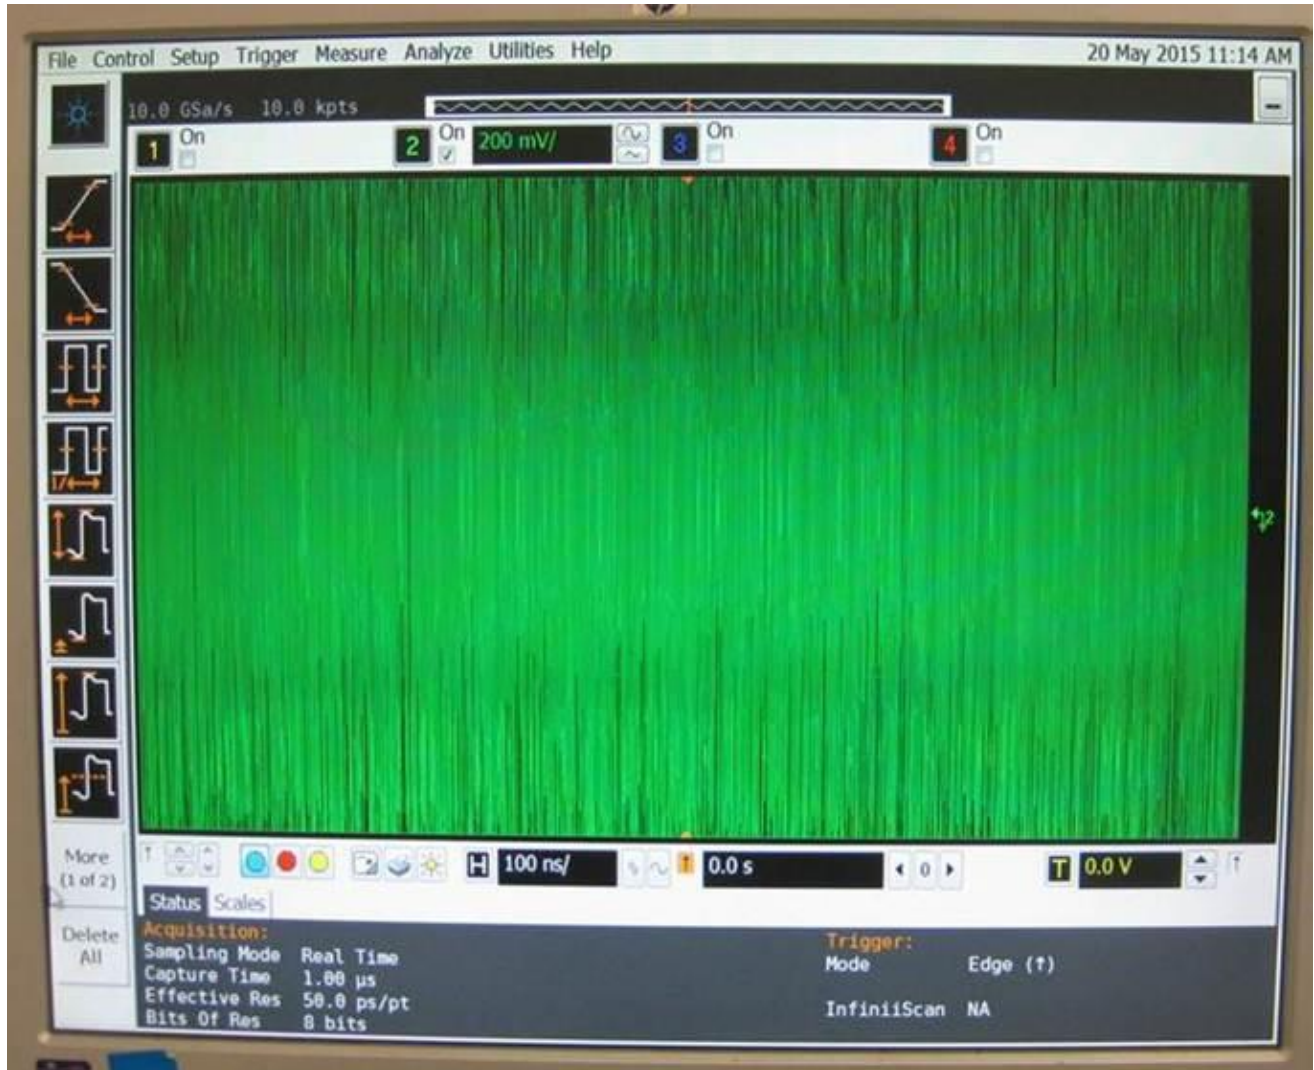
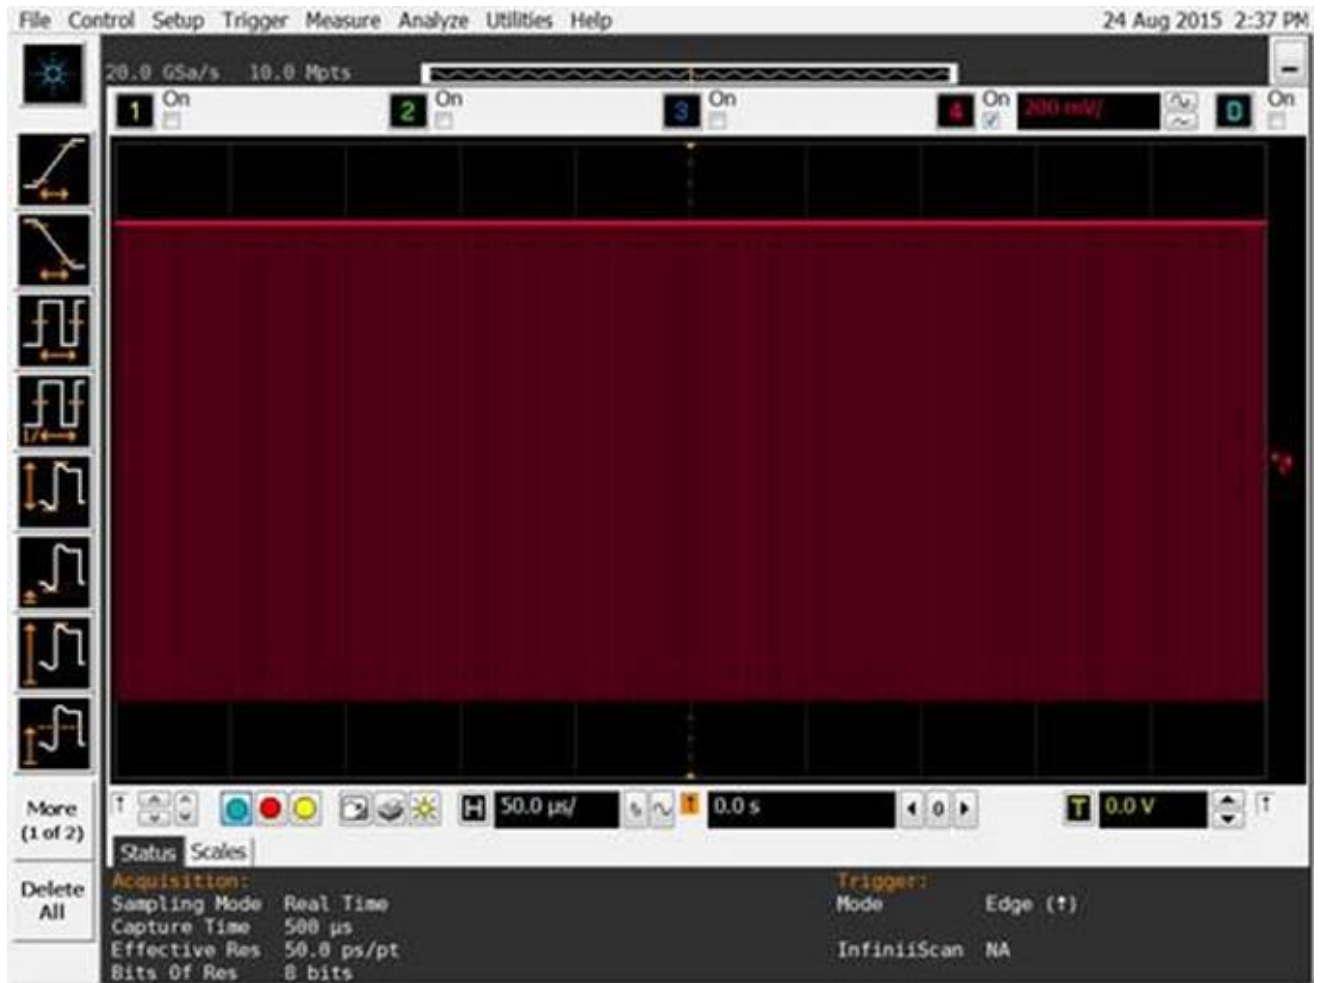
Upon completion of service or user calibration if the customer is not ok with upgrading the revision of software of the scope to >5.50.0033, there is a chance that the unit may end up with excessive noise on the screen at certain vertical settings.

1. Noise appears all over the screen after performing service/user calibration.
2. The noise on full screen could happen on any channel in 50 Ohm impedance on certain vertical settings. Some instances occurs at 200mV/div and not on other settings, whereas some occur at 10mV/div and not on other settings.

Here are some screenshots of the issue:

Solution/Action:  
Install revision of software 5.50.0033 or higher.
