MSO9404A-03

S E R V I C E N O T E

MSO9404A - 4GHz Mixed Signal Oscilloscope

Repair for Windows "Power surge on hub" message

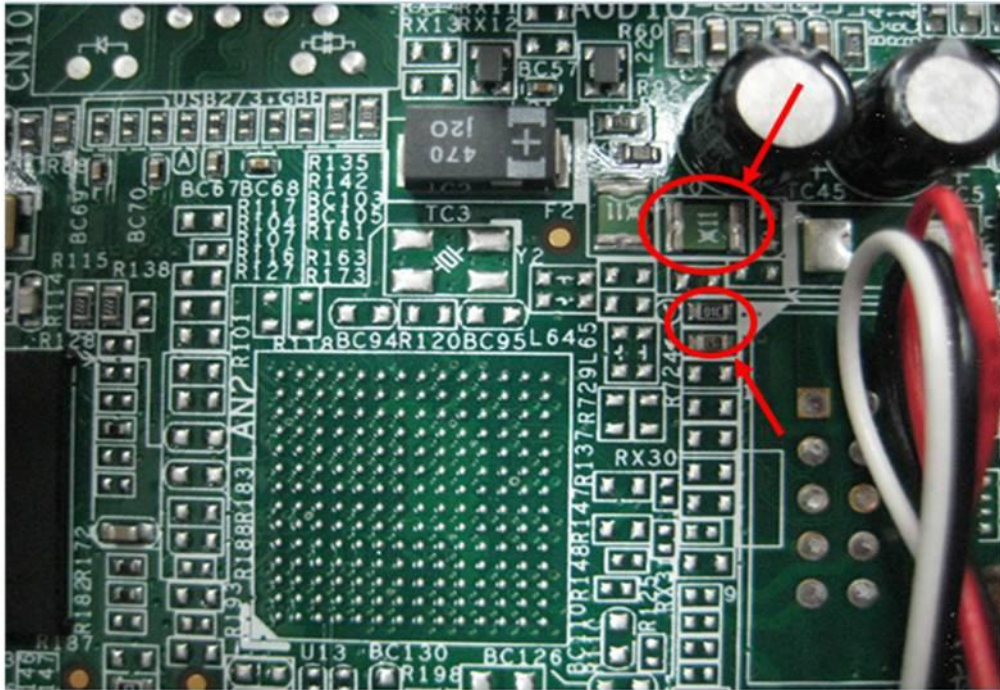
F10 – 0837-3854 Thermistor

R717 – 0699-7654 10K Resistor

R716 – 0699-5789 15K resistor

1. Refer to the service manual to remove the motherboard from the scope.
2. Install the three components from the upgrade kit on the motherboard. Refer to the below drawing and the drawing on the next page for component locations. The 0960-2789 motherboard is RoHS compliant and the below three components are also RoHS compliant. You should use a RoHS soldering station and RoHS solder techniques when possible.
