Modification Recommended Service Note

MSOS104A – MSO Infiniium S Series 1GHz 4 channel

The Problem – Under certain circumstances a PLL2 error may occur on the S-series products.

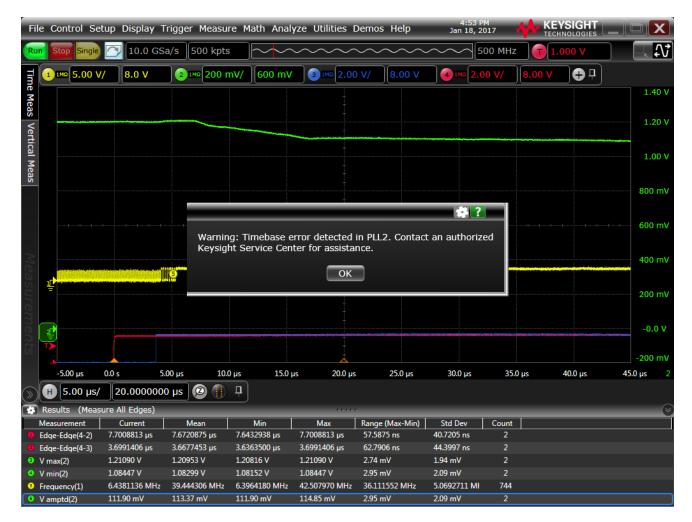
On older acquisition boards a PLL2 error message sometimes occurs. The error message appears on the screen as below:

There are new acquisition boards that fix this issue for the S-series scopes.

- 1. If the customer needs to have software revision < 6.10.01001, then replace the acquisition board with the 54911-69532 board.
- 2. If the customer can have software revision >= 6.10.01001, then it can be replaced by any of these three boards: 54911-69521, 54911-69531, or 54911-69532.
