MSOS404A-03D

Modification Recommended Service Note

MSOS404A – MSO Infiniium S Series 4GHz 4 channel

The Problem – Under certain circumstances a PLL2 error may occur on the S-series products.

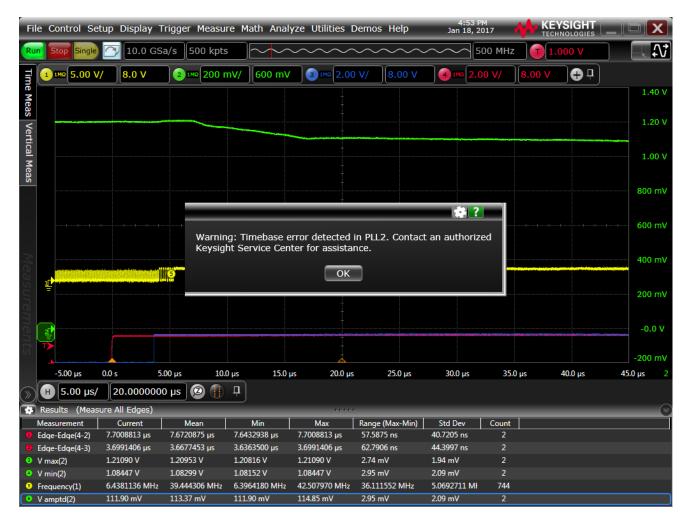
On older acquisition boards a PLL2 error message sometimes occurs. The error message appears on the screen as below:

There are new acquisition boards that fix this issue for the S-series scopes.

- 1. If the customer needs to have software revision < 6.10.01001, then replace the acquisition board with the 54911-69532 board.
- 2. If the customer can have software revision >= 6.10.01001, then it can be replaced by any of these three boards: 54911-69521, 54911-69531, or 54911-69532.
- 3. Save the Serial Numbers of the replaced and the new Acquisition Boards in Siebel. Please, follow this procedure:
 - a. For each Service Order in Siebel, there is a tab labeled Activities:
