MSOX2022A-03

SERVICE NOTE

MSOX2022A – Oscilloscope, Mixed Signal, 2+8 Channel, 200MHz

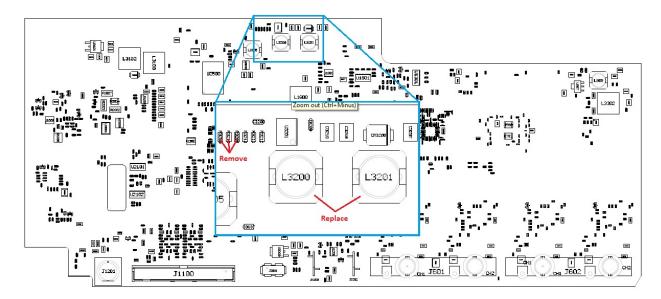
With the oscilloscope power turned on and while under normal operation, the unit emits a hissing noise.

- 2. As the picture indicates, remove the three resistors (0699-7209, 1 Ohm) located at R3208, R3209, and R3210. They are not to be replaced.
- 3. Remove as well the two inductors (9140-6474, 100uH) located at L3200 and L3201 and replace them with inductors with part number 9140-6151 (68 uH).
- 4. Re-assemble to the point where the unit could be powered up to verify that the hissing is indeed gone. If the hissing is not gone, please, check modifications.
- 5. When the hissing is gone, put oscilloscope back together.
