MSOX4154A-04-S

Safety Service Note

MSOX4154A Mixed Signal Oscilloscope: 1.5 GHz, 4 Analog Channels Plus 16 Digital Channels

POSSIBLE "SHOCK" HAZARD

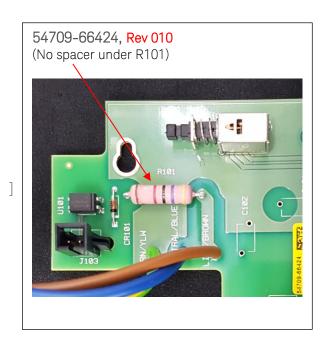
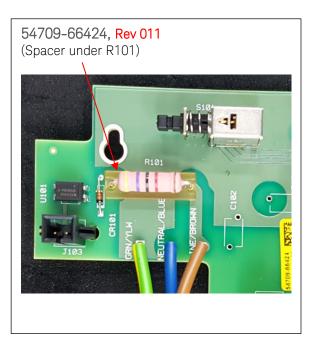
Over the past month, Keysight observed failures during the Routine Safety Test. Investigation found a recently changed R101 resistor, from a 39K ohm part to a new 47K ohm part is against the printed circuit board ground plane and insulation breakdown may cause a safety concern. This issue is limited to the serial numbers listed above.

Keysight addressed the issue by placing a spacer under the R101 resistor and updated the 54709-66424 line filter board from rev 010 to rev 011 to reflect the change. The rework on the oscilloscope, performed by a Keysight Service Center, replaces the rev 010 line filter board (54709-66424) with the rev 011 line filter board as specified in the Keysight InfiniiVision 4000 X-Series Oscilloscope Service Guide.

- Perform HiPot.
- Replace the 54709-66424, rev 010 line filter board with 54709-66424, version 011 line filter board as specified in the Keysight InfiniiVision 4000 X-Series Oscilloscope Service Guide. The difference between the two revisions is that rev 011 has a spacer under the 47K resister.
- Perform HiPot test
- Perform Hardware Self Test: Utility (key) → Service (softkey) → Hardware Self Test (softkey)
- Do Performance Verification (PV) as specified in the Keysight InfiniiVision 4000 X-Series Oscilloscope Service Guide
 - o If PV fails, perform User Calibration redo PV
