MX0025A-01

Modification Recommended Service Note

InfiniiMax Ultra 25 GHz Probe Amp with AutoProbe 2 Interface

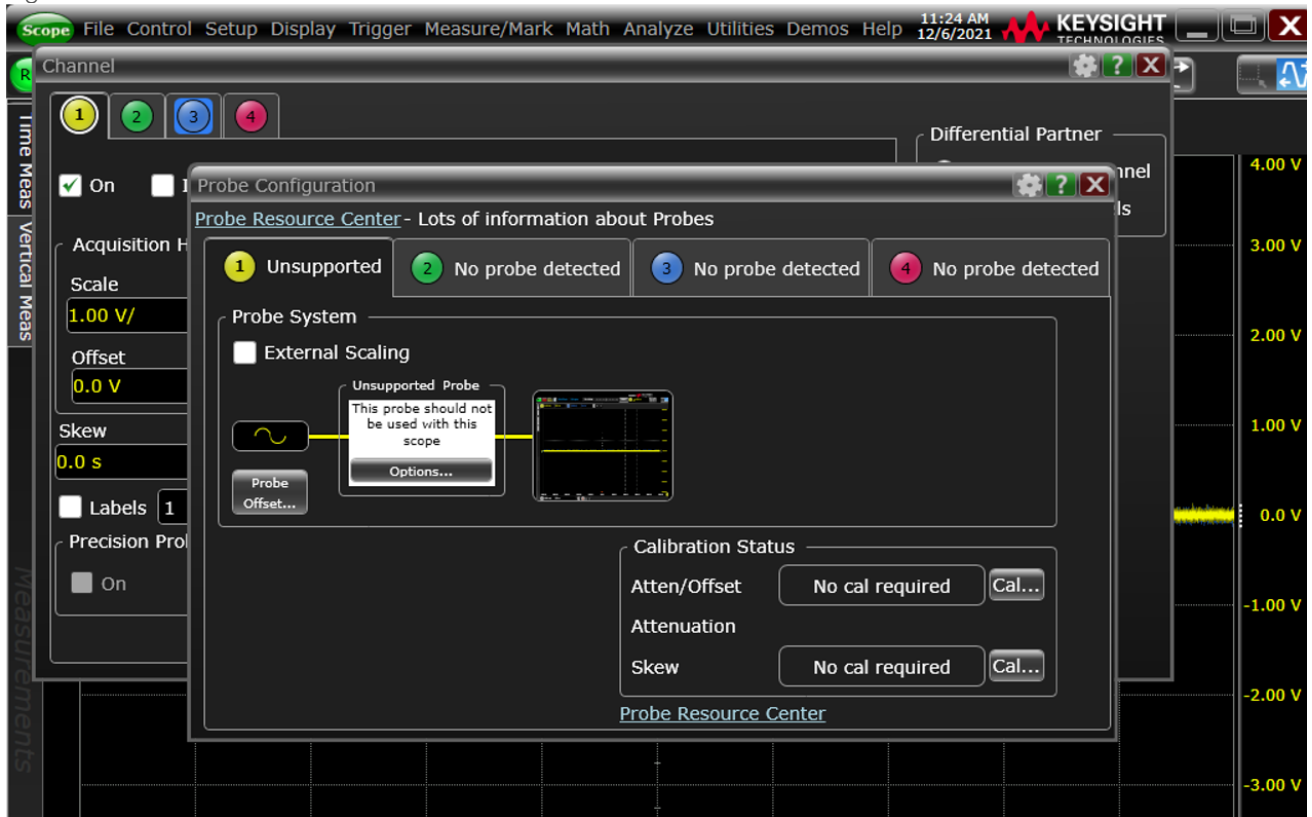
The early shipments of MX0025A probes have a quality concern that can cause probes to not be recognized when attached to the scope channel. Please see Figure 1.

- 1. Capacitor failure

Please return defective probe amplifier to service center for repair.
