N1090A-01

Modification Recommended Service Note

N1090A DCA-M Sampling Oscilloscope (Single Optical Channel)

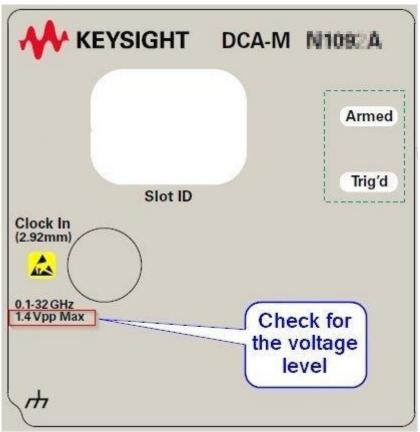
In May 2018, the clock's input port maximum signal voltage changed from 2.0 Vp-p (old value) to 1.4 Vp-p (new value). This is very sensitive circuitry and this change provides additional margin to reduce risk of damage to the instrument.

Figure 1 Updated overlay - should say 1.4 Vpp Max

If the front left panel overlay shows 2 Vp-p (old value), remove the old overlay and replace it with the new overlay that shows 1.4 Vp-p (new value). If the customer has added any asset tags, or other customer information to the old left front panel overlay, it is recommended to send back the old overlay to the customer after it has been removed.
