N1092A-01

Modification Recommended Service Note

N1092A DCA-M Sampling Oscilloscope (Single Optical Channel)

Replace the left front panel overlay that shows the new clock input level at 1.4 Vp-p Max.

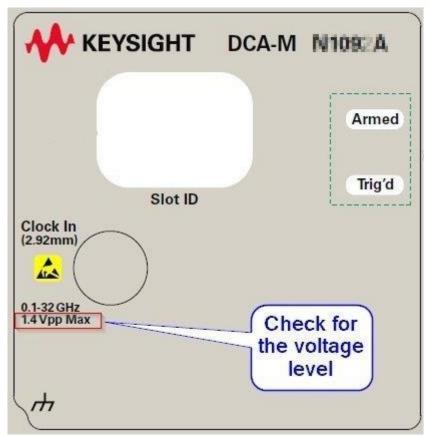
In May 2018, the clock's input port maximum signal voltage changed from 2.0 Vp-p (old value) to 1.4 Vp-p (new value). This is very sensitive circuitry and this change provides additional margin to reduce risk of damage to the instrument.

Figure 1 Updated overlay - should say 1.4 Vpp Max

If the front left panel overlay shows 2 Vp-p (old value), remove the old overlay and replace it with the new overlay that shows 1.4 Vp-p (new value). If the customer has added any asset tags, or other customer information to the old left front panel overlay, it is recommended to send back the old overlay to the customer after it has been removed.
