N2831A-01

# Modification Recommended Service Note

## N2831A 8 GHz InfiniiMax III+ Series Probe Amplifier

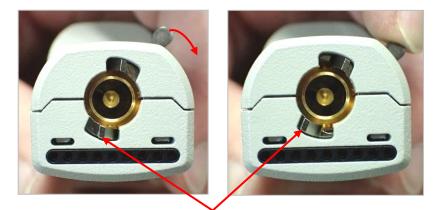
BNC tab rotates with BNC latch rotation

Test the BNC connector by rotating the wing latch clockwise, and verify the BNC tab rotates inside the pod housing.
