N2832A-02

# Modification Recommended Service Note

N2832A 13 GHz InfiniiMax III+ Series Probe Amplifier  
Serial Numbers: ALL

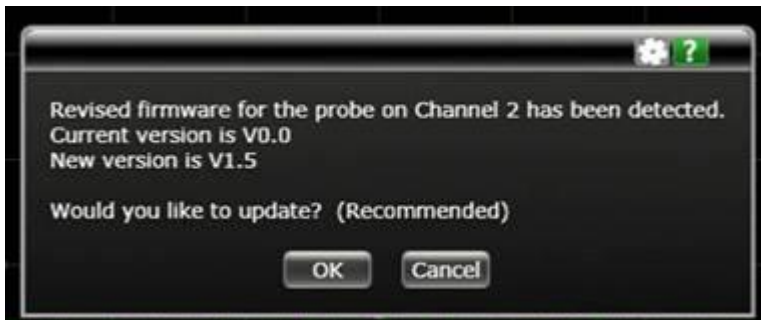
With older Infiniium Application SW versions, the probes microcontroller address can inadvertently be re-written. This will cause the probe to have an error message displayed on the scope when attached.

1. Ask the customer if he/she has seen the following message when plugging his/her probe onto an oscilloscope:

2. Regardless of the customer's answer to the question, plug the customer's probe onto a Service Center scope with software version 06.20.00701 or later.
3. If the Customer said No in step 1 or was unsure: tell the customer that Keysight recommends downloading latest scope software version—Version 06.20.00701 or later. Continue with standard procedure.
4. If the Customer said Yes, the probe appears to function normally on the scope, and it passes calibration, the probe has been fixed. Send the original probe back to the customer, and tell the customer that Keysight recommends an upgrade to oscilloscope software—Version 06.20.00701 or later to prevent this issue from re-occurring to their probe.
