N3383A-04A <u>S E R V I C E N O T E</u>

N3383A PNA Series RF Network Analyzers

Replace Inverter board (0950-3379) due to faulty component.

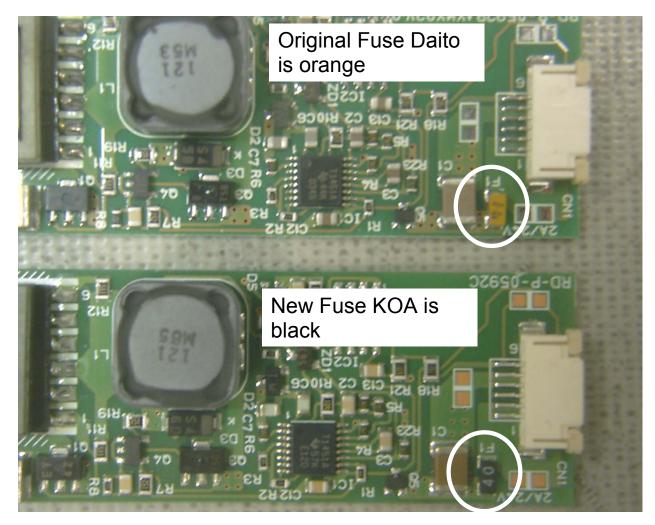
The original fuse (see photo) in the DC/AC Inverter board (p/n 0950-3379) is prone to failure in normal use.

Replace the Inverter board with a board containing the new fuse (see photo).
