N4010A-04

S E R V I C E N O T E

N4010A Wireless Connectivity Test Set

Damaged Line Module Causes Instrument To Intermittently Re-boot

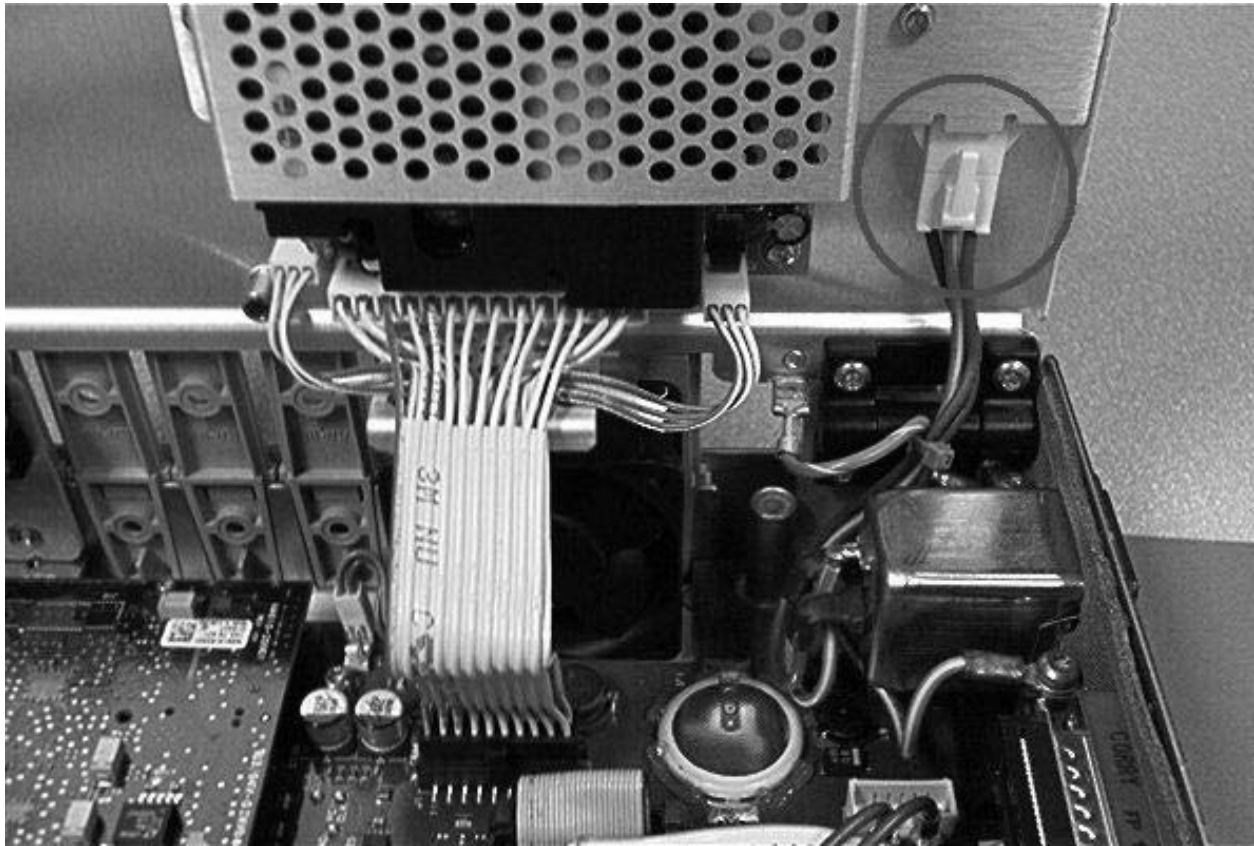
Figure 1: Line Module Connector (Attached To The Deck Assembly)

1. Ensure the instrument is not connected to a mains power supply.
2. Loosen the five captive screws on the bottom of the instrument.
3. Remove the top cover from the instrument.
4. [Option 102/103 units only] Disconnect the semi-rigid cables from ports 2 & 3 of the RF Switch.
5. Lift the hinged deck assembly into the vertical position.
6. Disconnect the white line module connector from the deck assembly (refer to Figure 1).
7. Inspect the terminals of the white line module connector for signs of damage (refer to Figures 2 and 3).

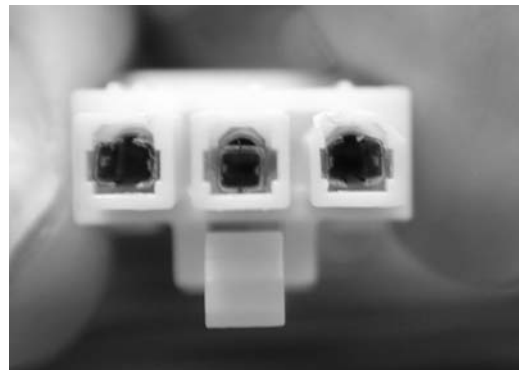
Figure 3: Example – Damaged Connector

A manufacturing defect has resulted in damage to the line module of some N4010A instruments. The outer terminals (live and neutral) of a connector inside the N4010A have been forced open, which can cause an intermittent connection with the mating connector on the power supply unit. The center terminal (earth) of the line module connector is unaffected.

Units that have a damaged line module may exhibit one or both of the following faults:

1. The unit may intermittently re-boot.
2. The unit may generate an audible electrical crackling noise.

The damaged line module has been assessed with respect to electrical shock & fire hazards. In both instances, this damage has been judged to be non-hazardous.

If the line module is damaged, it must be replaced. Once the instrument has been re-assembled, it must be tested to ensure it meets electrical safety requirements.
