N4010A-08A**S E R V I C E****N O T E**Supersedes:
N4010A-08**N4010A Wireless Connectivity Test Set****Serial Numbers: MY46320256 / MY47230414**

RF Assembly Reliability Issue**To Be Performed By: Agilent-Qualified Personnel****Parts Required:**

March 20, 2008

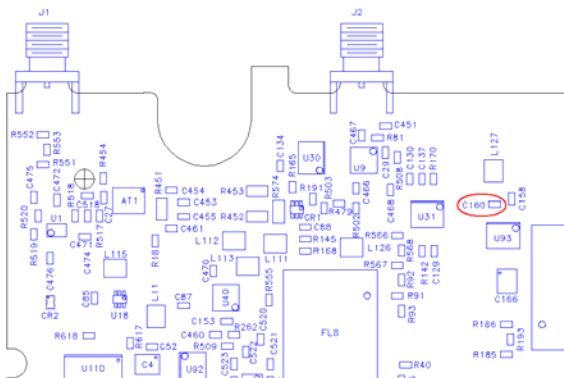
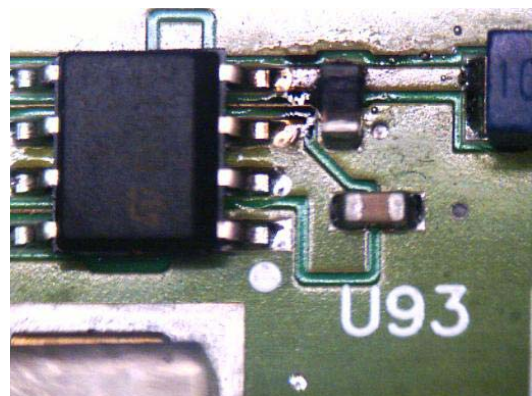
Figure 3

- (c) Refer to Figures 3 and 4:
Locate capacitor C160, and check to see if it is burned-out. If it is burned-out then the complete RF Assembly must be replaced (part number N4010-69870). If it is not burned out then proceed to step 2(e).

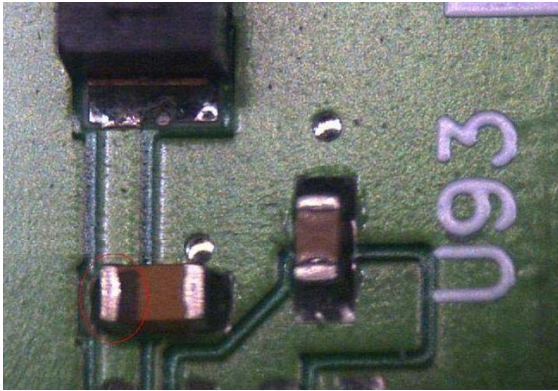
*Figure 5*

- (e) The polarity of C160 is indicated by a dark brown stripe at the positive electrode. The correct orientation of C160 is shown in Figure 5, whilst Figure 6 shows the wrong orientation of C160. If the orientation of C160 is correct, then proceed to step 2(h), otherwise continue to step 2(f).

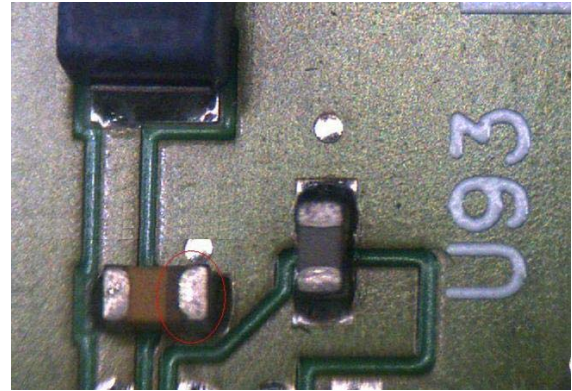
*Figure 6*

This Service Note addresses a manufacturing defect that was introduced to the N4010A RF Assembly during 2007 that went undetected for several months. This error relates to the placement of a 1uF tantalum capacitor on a low DC voltage supply line – the capacitor was fitted using the wrong polarity, causing it to de-rate over time. If the capacitor de-rates to the point that it fails, the N4010A RF Assembly will no longer work correctly.
