N4010A-08B <u>S E R V I C E N O T E</u>

Supersedes: N4010A-08A

N4010A Wireless Connectivity Test Set

RF Assembly Reliability Issue

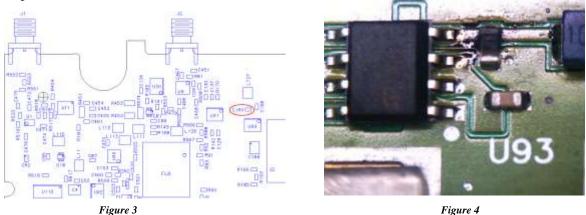
Locate capacitor C160, and check to see if it is burned-out. If it <u>is</u> burned-out then the complete RF Assembly must be replaced (part number N4010-69870). If it is <u>not</u> burned out then proceed to step 2(e).

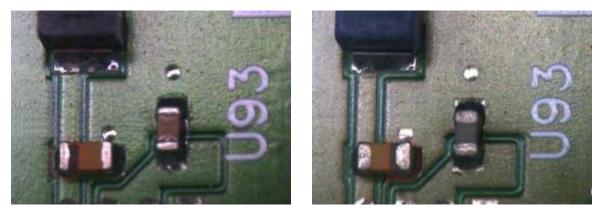
(e) The polarity of C160 is indicated by a dark brown stripe at the positive electrode. The correct orientation of C160 is shown in Figure 5, whilst Figure 6 shows the wrong orientation of C160. If the orientation of C160 is <u>correct</u>, then proceed to step 2(h), otherwise continue to step 2(f).

(f) Use a hot air solder station (set to 380°C) & tweezers to remove C160 as shown in Figure 7. Use the same settings to heat the solder on the pad and replace C160 (part number 0181-0233). Note: Do not apply hot air directly to the device, as it may be damaged by over-heating.
