**N4010A-09**

**S E R V I C E N O T E**

**N4010A Wireless Connectivity Test Set**

**Firmware Defect May Affect The N4010A Noise Floor**

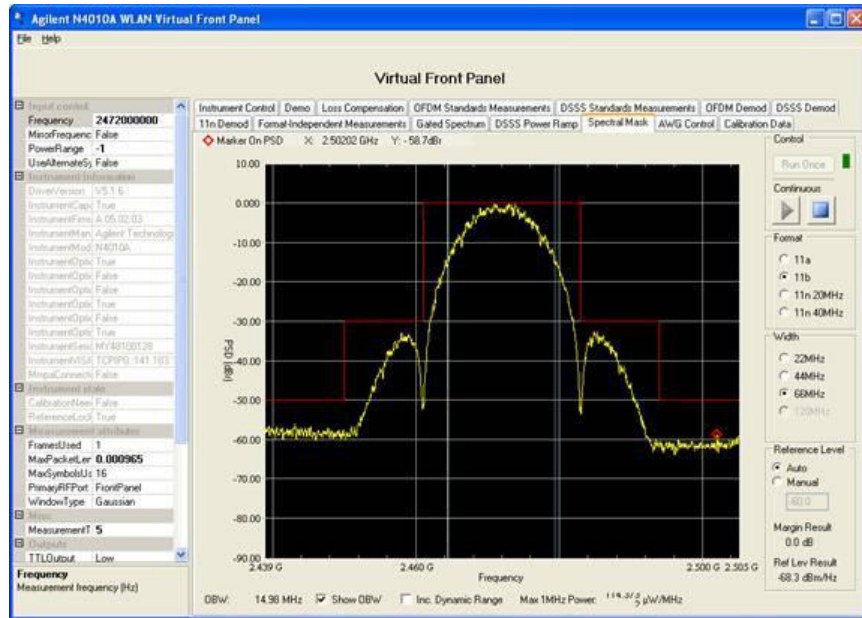
Figure 1

1. Connect the N4010A to an 802.11b WLAN device, and configure the device to transmit a repeated signal.
2. Launch the N4010A 'Virtual Front Panel' software; create a connection between the software and the N4010A.
3. Select the 'Instrument Control' tab; auto-range & set the power level for an 802.11b signal.
4. Select the 'Spectral Mask' tab; select 'Format 11b', 'Width 66MHz', and click on 'Run Once'.
5. If the spectral mask result is similar to Figure 1, then the fault is not present in this instrument.
6. If the spectral mask result is similar to Figure 2, then the fault is present in this instrument.

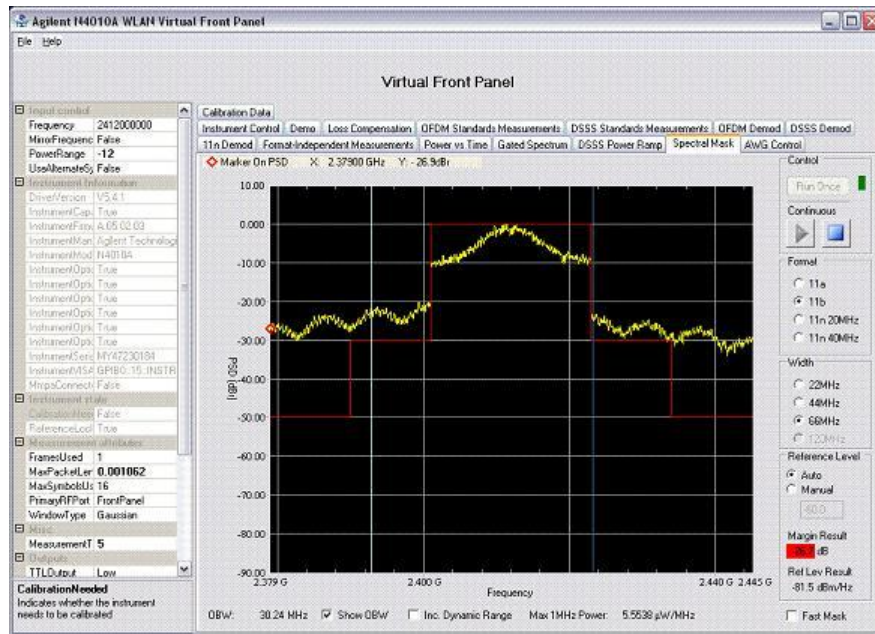
Figure 2

A firmware defect has been found that may cause the noise floor of the N4010A to shift by as much as +30dB; when this happens the instrument will fail measurements such as spectral mask, even on a good device. This defect is present in all firmware revisions prior to A.05.03.10.

This fault can be fixed by simply upgrading the N4010A firmware to revision A.05.03.10 (or later).
