N4690D-02

Modification Recommended Service Note

N4690D Electronic Calibration Module (ECal)

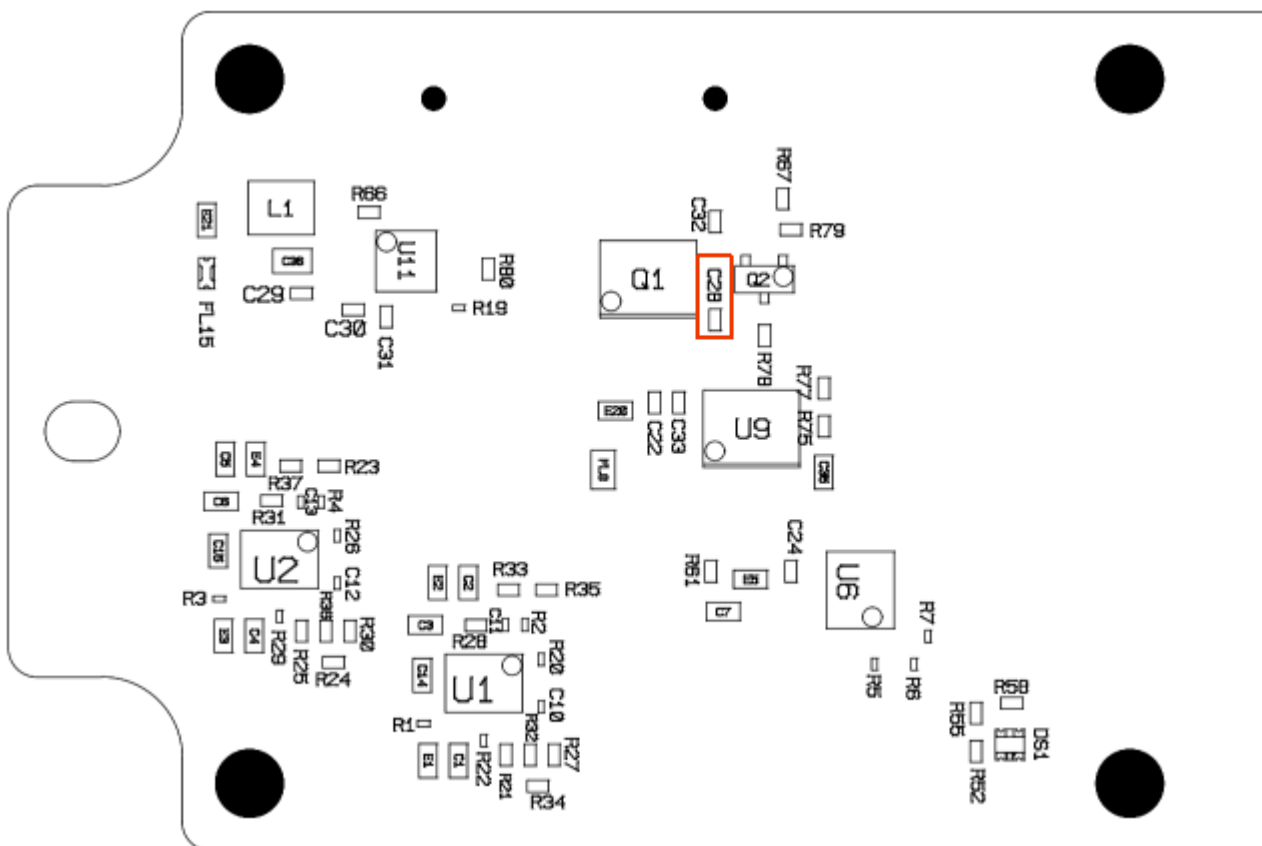
The heater circuit in the N469xD ECal modules was initially designed with a dampening capacitor. It was found in a small number of ECal modules that a resonance can develop in this circuit after the modules is warmed up. This resonance can cause an RF tone between 140 MHz and 150 MHz to be injected onto the signal path.

Open the ECal module and remove the N4690-63004 printed circuit board. On this board, locate the C28 capacitor indicated here:

If this capacitor has been removed, no further action is required. Reassemble the ECal module.

If this capacitor exists on this board, this capacitor should be carefully unsoldered and removed, or the N4690-63004 printed circuit assembly should be replaced. Once this is done, reassemble the ECal module.
