Modification Recommended Service Note

N4690D Electronic Calibration Module (ECal)

Serial Numbers: MY57450000- MY59410001

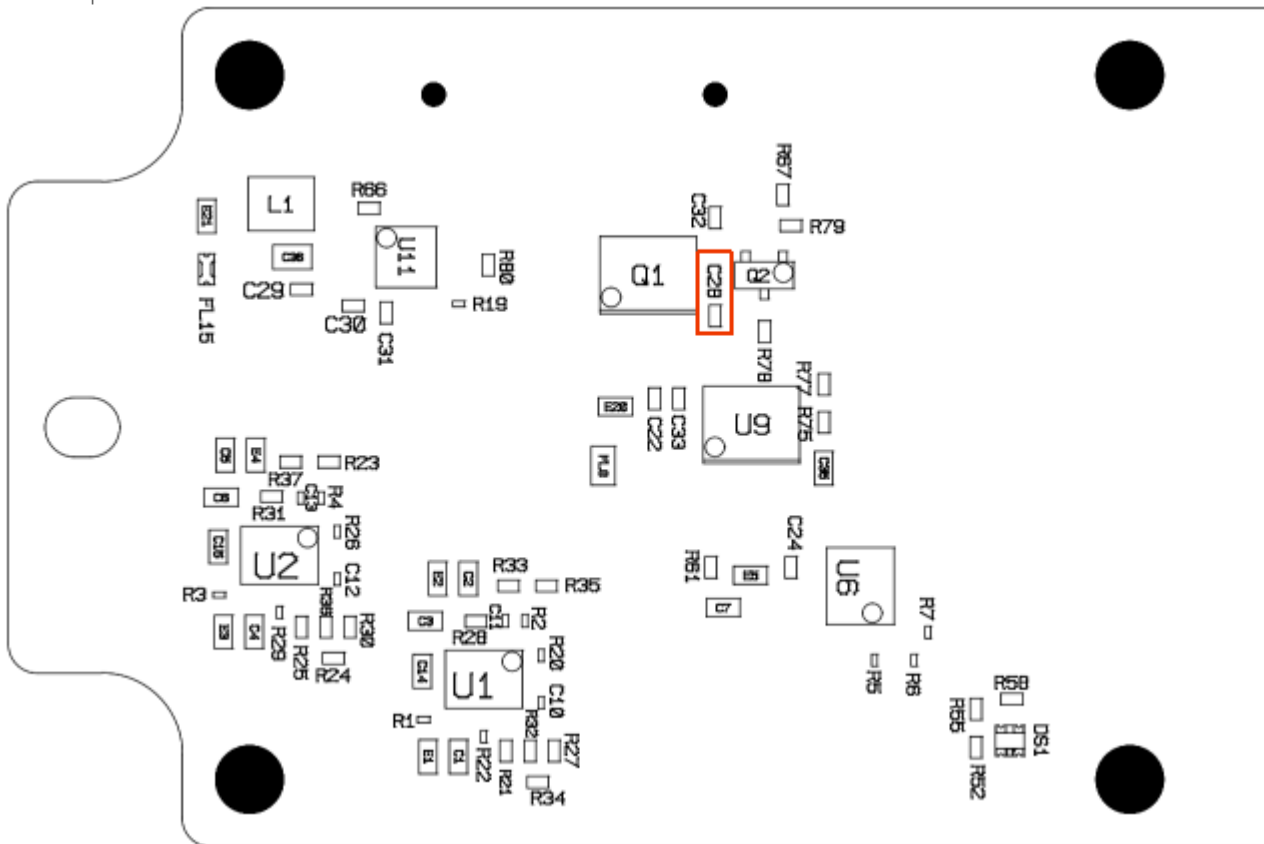
The heater circuit in the N469xD ECal modules was initially designed with a dampening capacitor. It was found in a small number of ECal modules that a resonance can develop in this circuit after the modules is warmed up. This resonance can cause an RF tone between 140 MHz and 150 MHz to be injected onto the signal path. The dampening capacitor was eliminated in all ECal modules with serial prefix MY5941 and above.

Open the ECal module and remove the N4690-63004 printed circuit board. On this board, locate the C28 capacitor indicated here:

If this capacitor has been removed, no further action is required. Reassemble the ECal module.

If this capacitor exists on this board, this capacitor should be carefully unsoldered and removed, or the N4690-63004 printed circuit assembly should be replaced. Once this is done, reassemble the ECal module.
