# Modification Recommended Service Note

Supersedes:  
N4691D-02

## N4691D Electronic Calibration Module (ECal)

Serial Numbers: MY57450000- MY59410001

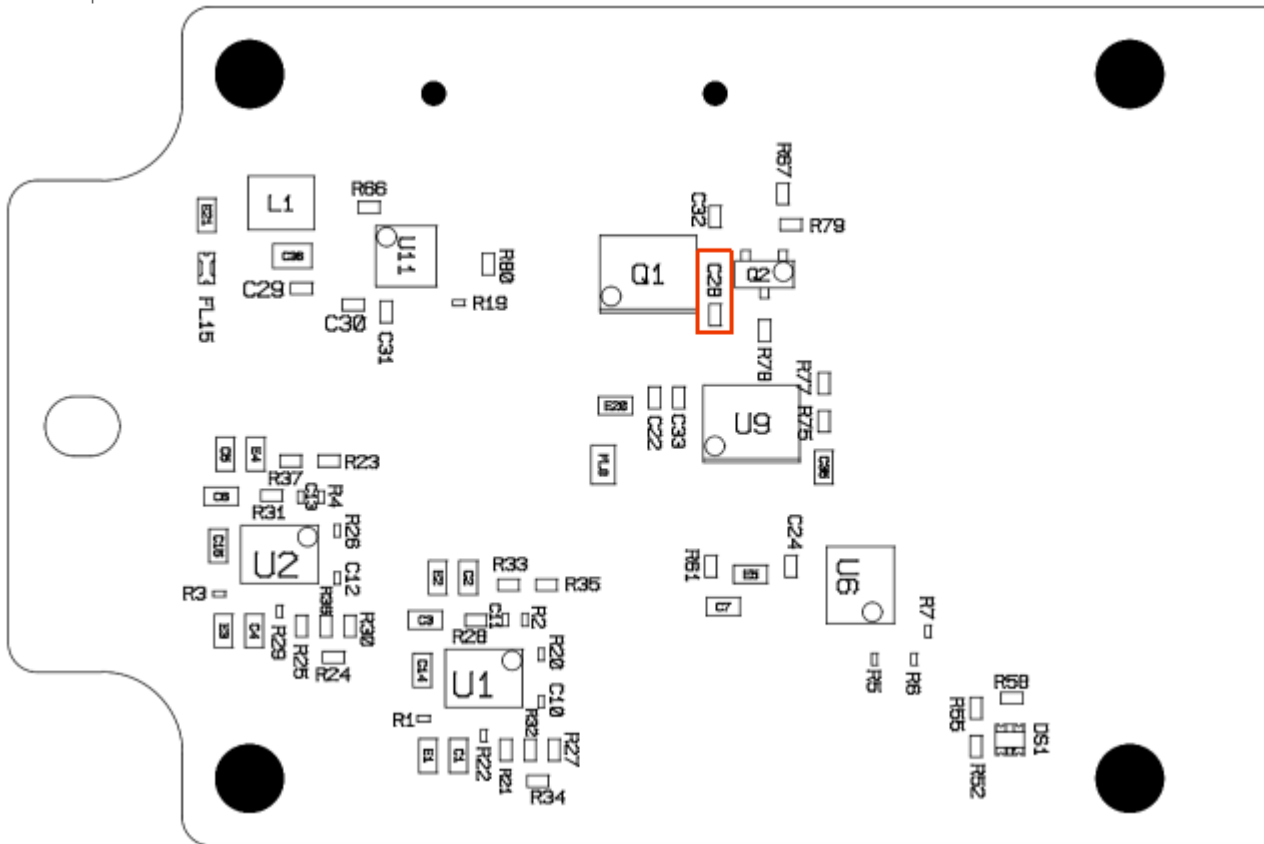
The heater circuit in the N469xD ECal modules was initially designed with a dampening capacitor. It was found in a small number of ECal modules that a resonance can develop in this circuit after the modules is warmed up. This resonance can cause an RF tone between 140 MHz and 150 MHz to be injected onto the signal path.

Open the ECal module and remove the N4690-63004 printed circuit board. On this board, locate the C28 capacitor indicated here:

If this capacitor has been removed, no further action is required. Reassemble the ECal module.

If this capacitor exists on this board, this capacitor should be carefully unsoldered and removed, or the N4690-63004 printed circuit assembly should be replaced. Once this is done, reassemble the ECal module.
