# Modification Recommended Service Note

## N4692D Electronic Calibration Module (ECal)

Serial Numbers: MY57450000- MY59410001

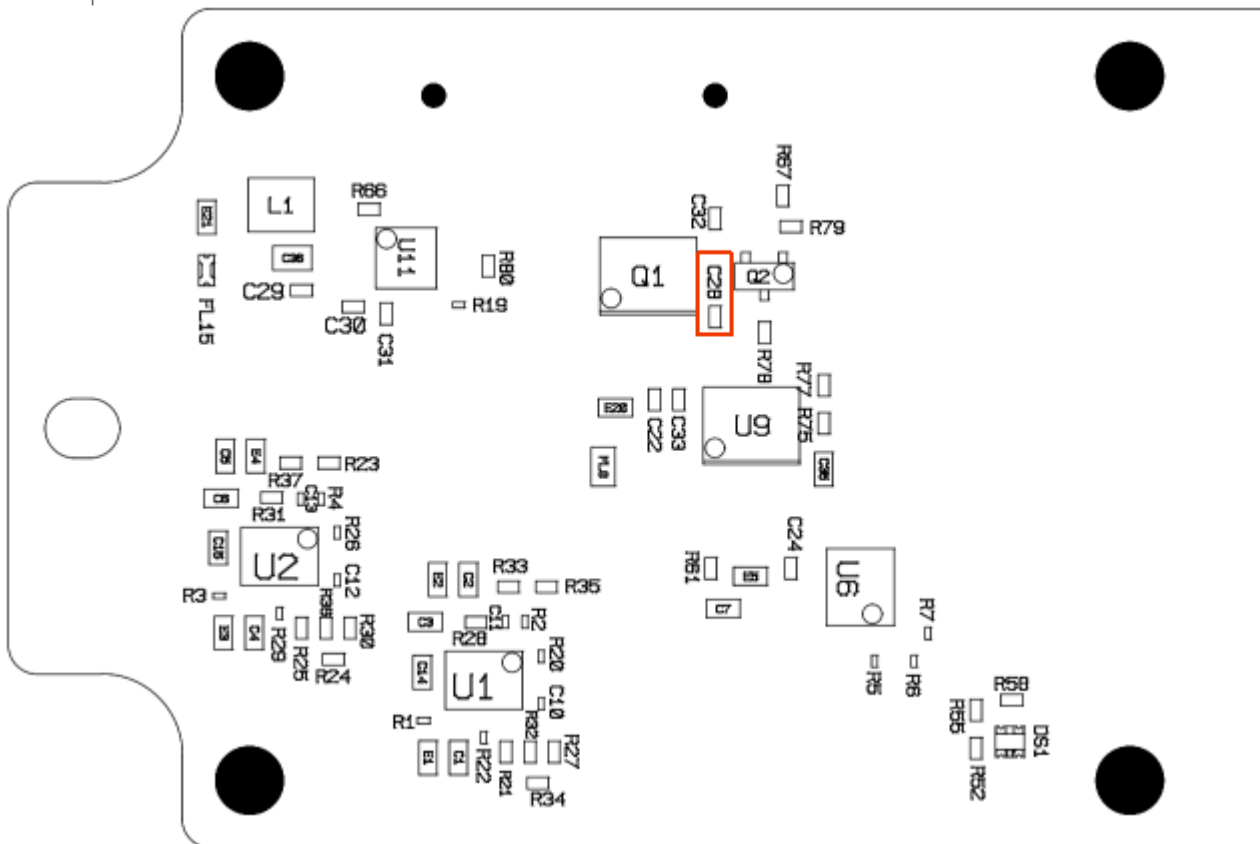
The heater circuit in the N469xD ECal modules was initially designed with a dampening capacitor. It was found in a small number of ECal modules that a resonance can develop in this circuit after the modules is warmed up. This resonance can cause an RF tone between 140 MHz and 150 MHz to be injected onto the signal path.

Open the ECal module and remove the N4690-63004 printed circuit board. On this board, locate the C28 capacitor indicated here:

If this capacitor has been removed, no further action is required. Reassemble the ECal module.

If this capacitor exists on this board, this capacitor should be carefully unsoldered and removed, or the N4690-63004 printed circuit assembly should be replaced. Once this is done, reassemble the ECal module.
