N4901A-01A-S

S E R V I C E N O T E

N4901A - Serial Bert 13.5 Gb/s

POSSIBLE FIRE HAZARD

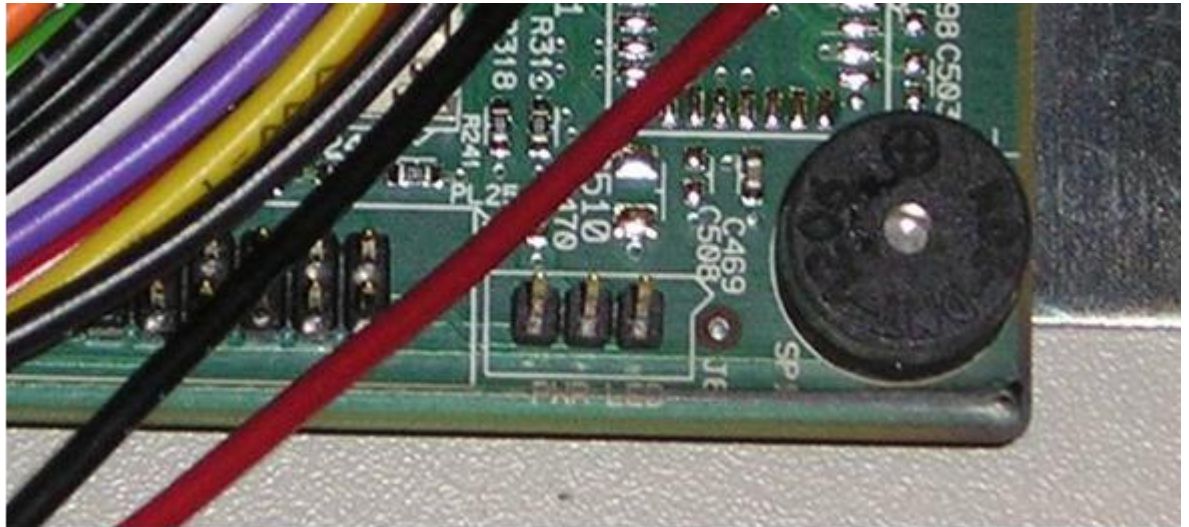
There might be discoloring on the PC motherboard in the shown corner (brown color). This can be ignored. The function or the quality of the motherboard is not affected by this.

Motherboard still considered being good – no exchange required:

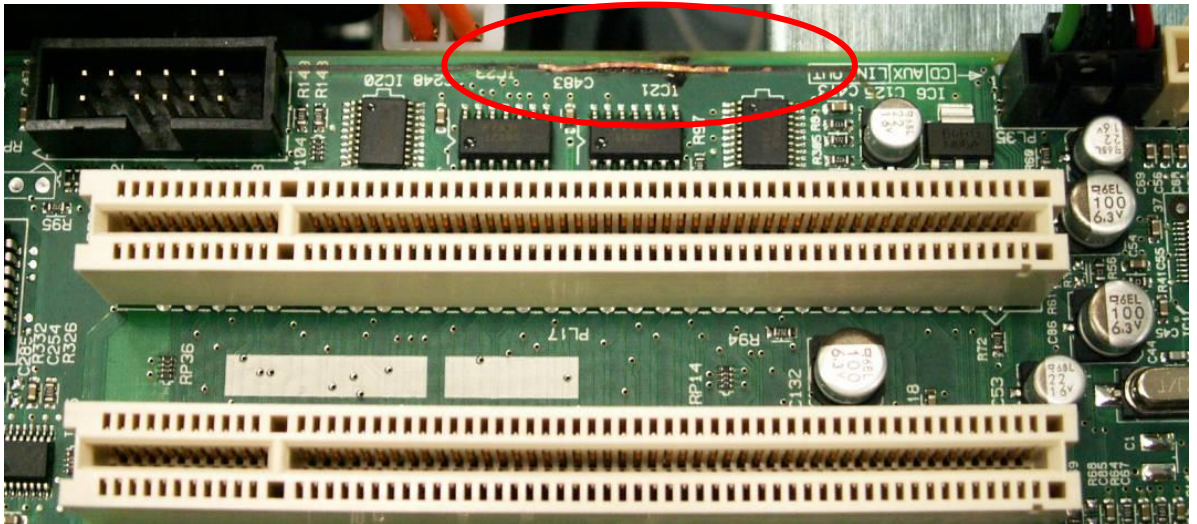
In very exceptional cases if you see traces of smoke or fire, the motherboard needs to be exchanged. In these cases typically the integrated display of the instrument would not work anymore. The exchange of the motherboards can only be done in the Service Center - onsite repair is not possible.

Motherboard considered being bad – please exchange:

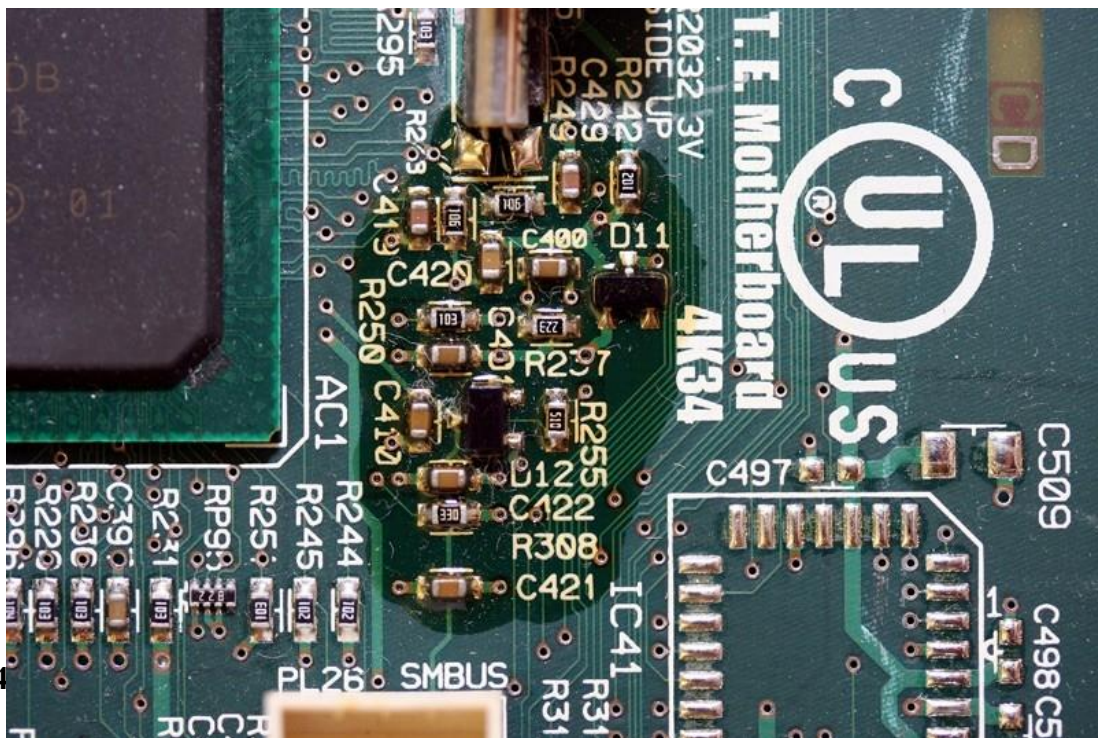
The following discoloring is intentional – no exchange required:

This effect is caused by an intentional sealing of a high impedance area to avoid issues in environments with a high degree of humidity. No exchange of the motherboard is required here.
