N4901B-01A-S

S E R V I C E N O T E

N4901B - Serial Bert 13.5 Gb/s

POSSIBLE FIRE HAZARD

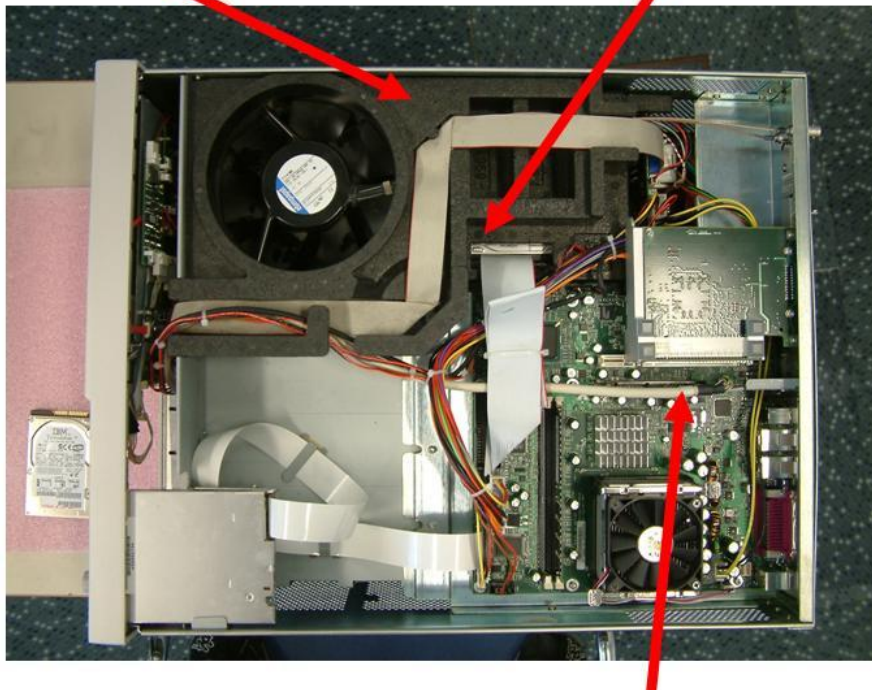
A surface-mount ceramic capacitor suffered physical stress during the manufacturing process, leading the capacitor to crack. During operation this crack placed stress on the internal structure of the capacitor, and caused the plates to short together. (The plates are separated by very little space, made up of very thin insulators.) This caused the capacitor to have very low residual impedance, resulting in a very high current conducted through the capacitor and the 12V path on the motherboard for some period of time. The low impedance didn't lead to a current high enough for blowing the fuse. Therefore the higher current was available long enough to create a very high temperature ($T > 300^{\circ}\text{C}$). The high temperature ignited the polyurethane molding used to conduct the airflow for cooling through the instrument.

The following photo illustrates the layout of the instrument. It shows the polypropylene molding, the graphics card and the starting point of the fire.

Polypropylene Molding**Start of Fire**

**Graphics Card**

The countermeasure for this issue is to exchange the graphics cards. The new graphics cards are produced with an improved manufacturing process eliminating the risk of micro cracks. They either have an additional fusing to protect the 12V path or they have eliminated the 12V path altogether. The graphics card can be exchanged by Agilent authorized personnel only.

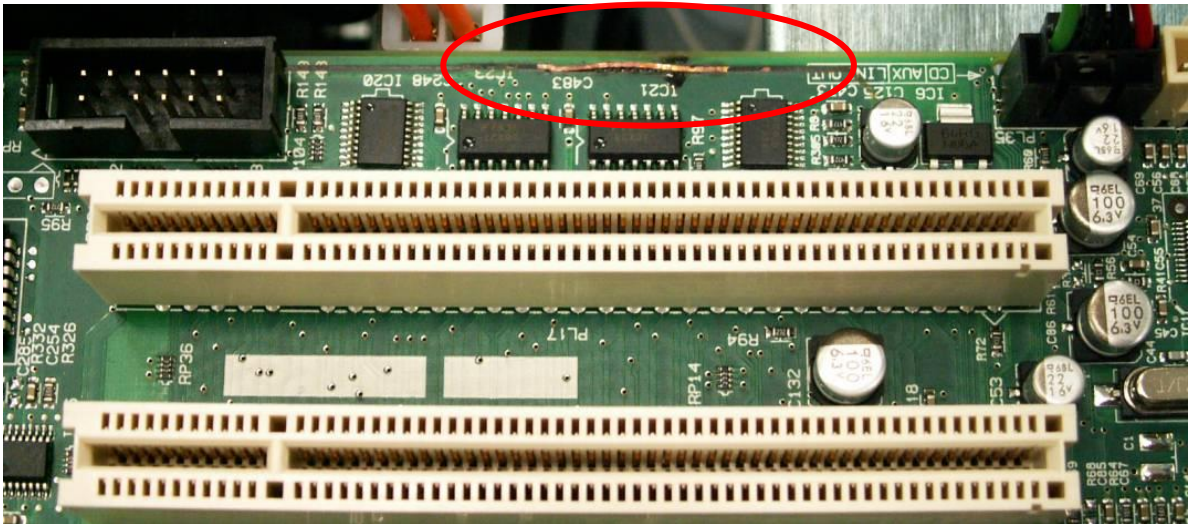
In very exceptional cases if you see traces of smoke or fire, the motherboard needs to be exchanged. In these cases typically the integrated display of the instrument would not work anymore. The exchange of the motherboards can only be done in the Service Center - onsite repair is not possible.

Motherboard considered being bad – please exchange:

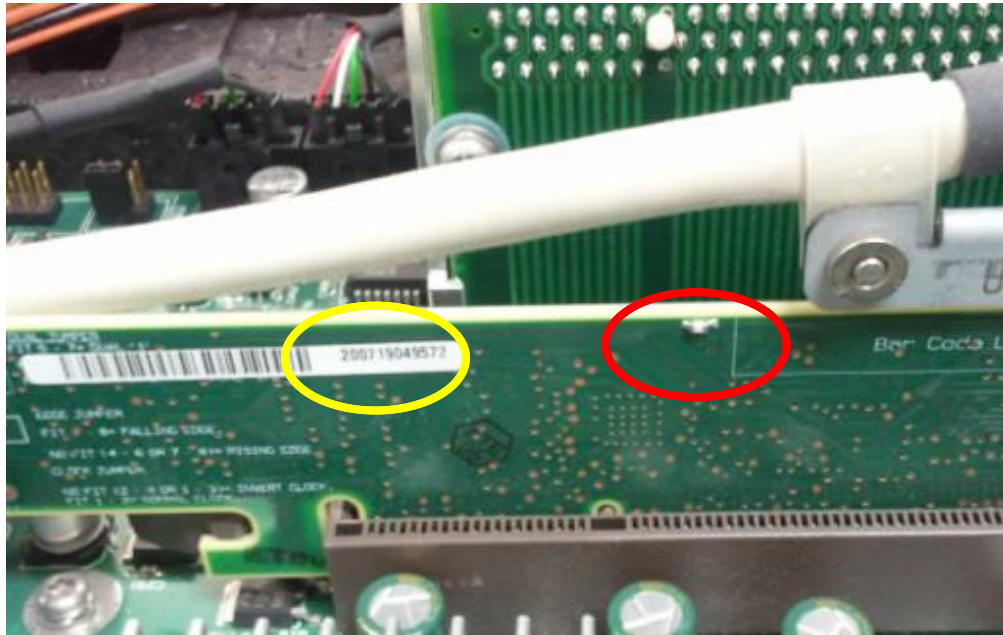
The board has a fuse on top (red circle) and a serial number (yellow circle) starting with 200... In the case above it is 200719049572)

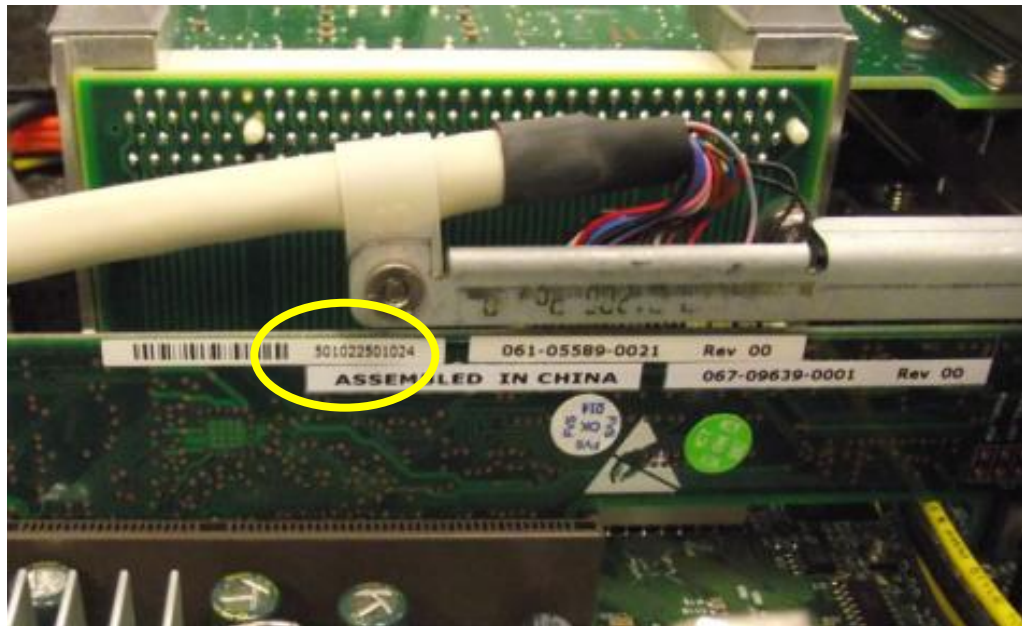
- Sample #2 (Revision NM2502):

The board has a serial number (yellow circle) **NOT** starting with 200... In the case above it is: 501022501024.
