N4902B-01A-S

S E R V I C E N O T E

N4902B - Serial BERT 7 Gb/s

POSSIBLE FIRE HAZARD

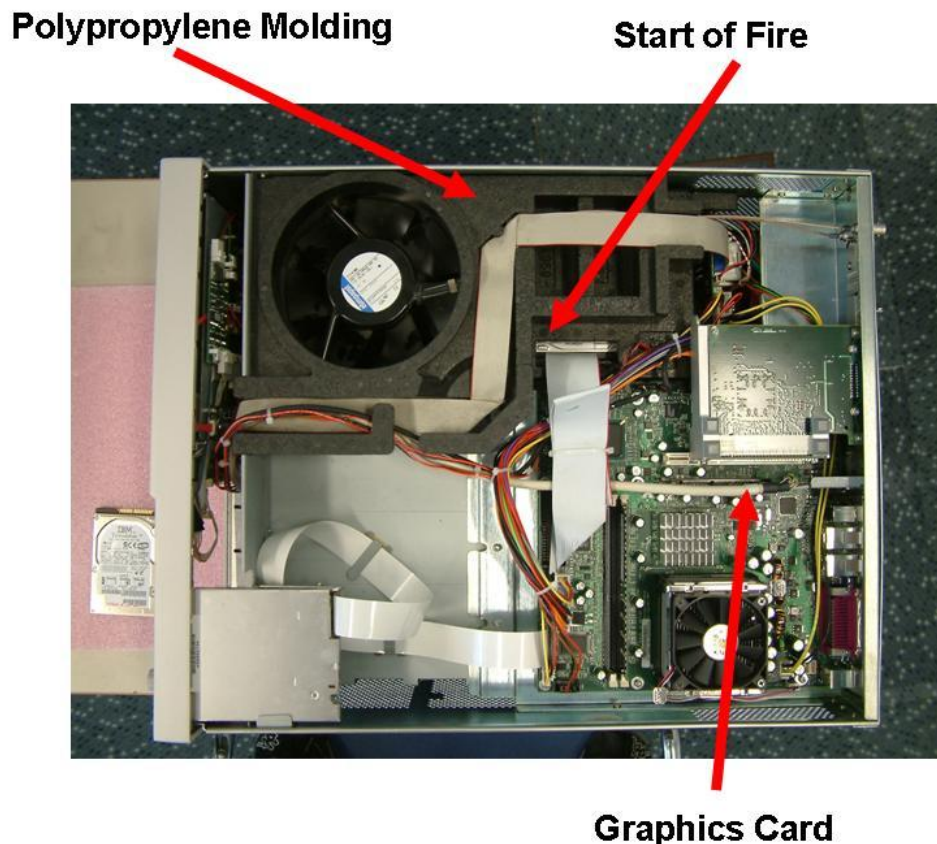
A surface-mount ceramic capacitor suffered physical stress during the manufacturing process, leading the capacitor to crack. During operation this crack placed stress on the internal structure of the capacitor, and caused the plates to short together. (The plates are separated by very little space, made up of very thin insulators.) This caused the capacitor to have very low residual impedance, resulting in a very high current conducted through the capacitor and the 12V path on the motherboard for some period of time. The low impedance didn't lead to a current high enough for blowing the fuse. Therefore the higher current was available long enough to create a very high temperature ($T > 300^{\circ}\text{C}$). The high temperature ignited the polyurethane molding used to conduct the airflow for cooling through the instrument.

The following photo illustrates the layout of the instrument. It shows the polypropylene molding, the graphics card and the starting point of the fire.

The countermeasure for this issue is to exchange the graphics cards. The new graphics cards are produced with an improved manufacturing process eliminating the risk of micro cracks. They either have an additional fusing to protect the 12V path or they have eliminated the 12V path altogether. The graphics card can be exchanged by Agilent authorized personnel only.

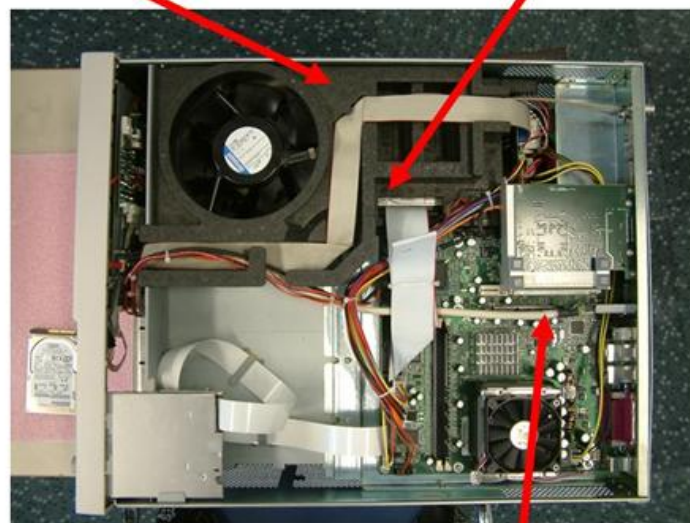
2. Inside View and Initial Inspection

Polypropylene Molding

Start of Fire

Graphics Card

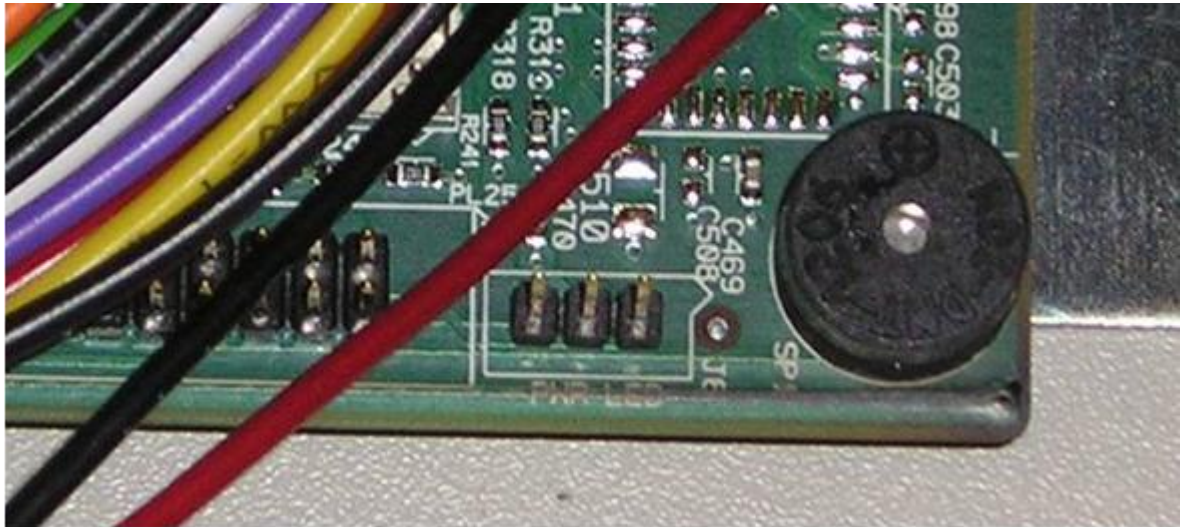
There might be discoloring on the PC motherboard in the shown corner (brown color). This can be ignored. The function or the quality of the motherboard is not affected by this.

Motherboard still considered being good – no exchange required:

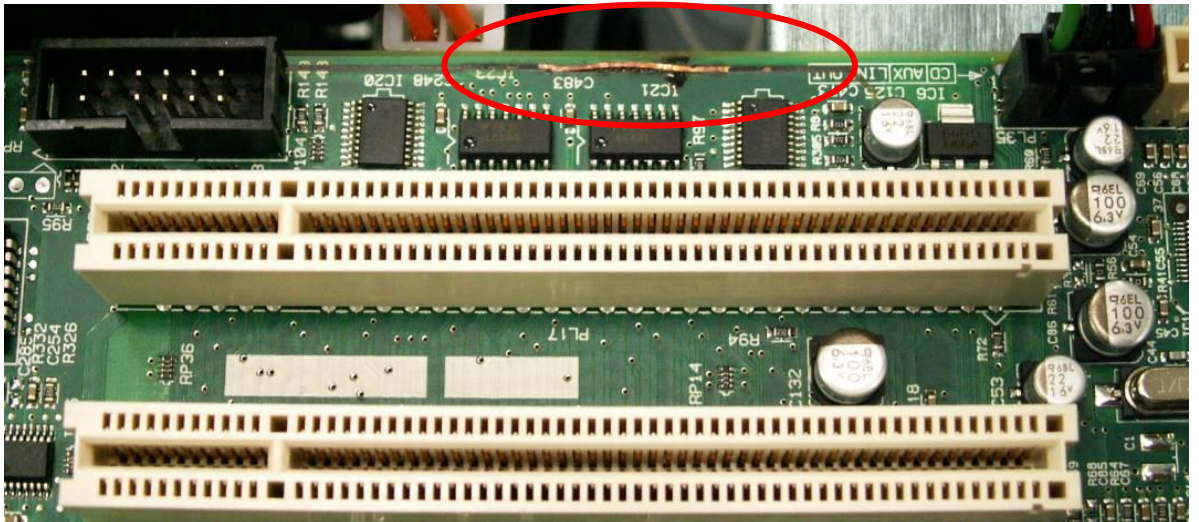
In very exceptional cases if you see traces of smoke or fire, the motherboard needs to be exchanged. In these cases typically the integrated display of the instrument would not work anymore. The exchange of the motherboards can only be done in the Service Center - onsite repair is not possible.

Motherboard considered being bad – please exchange:

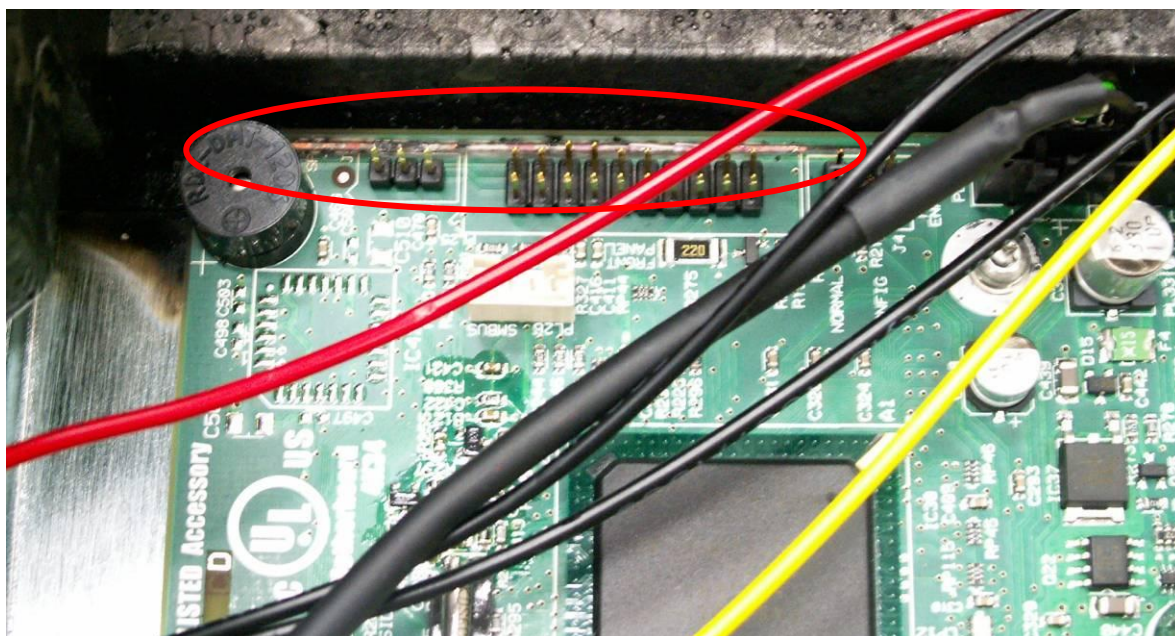
Motherboard considered being bad – please exchange:

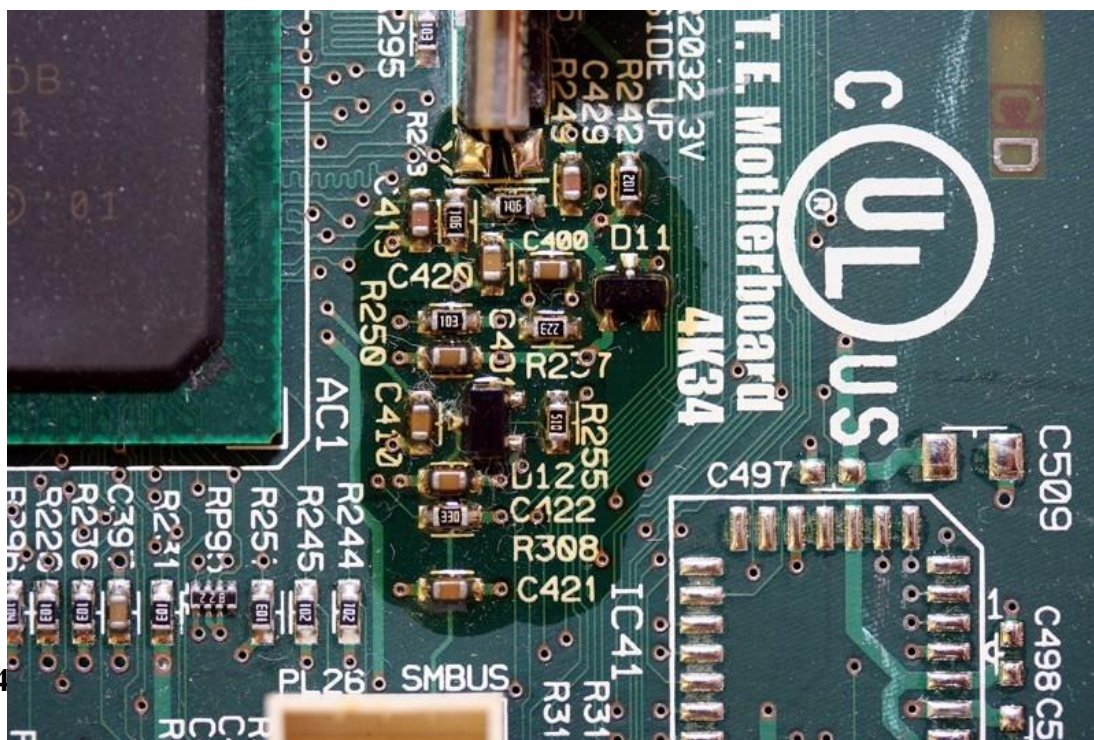
The following discoloring is intentional – no exchange required:

This effect is caused by an intentional sealing of a high impedance area to avoid issues in environments with a high degree of humidity. No exchange of the motherboard is required here.

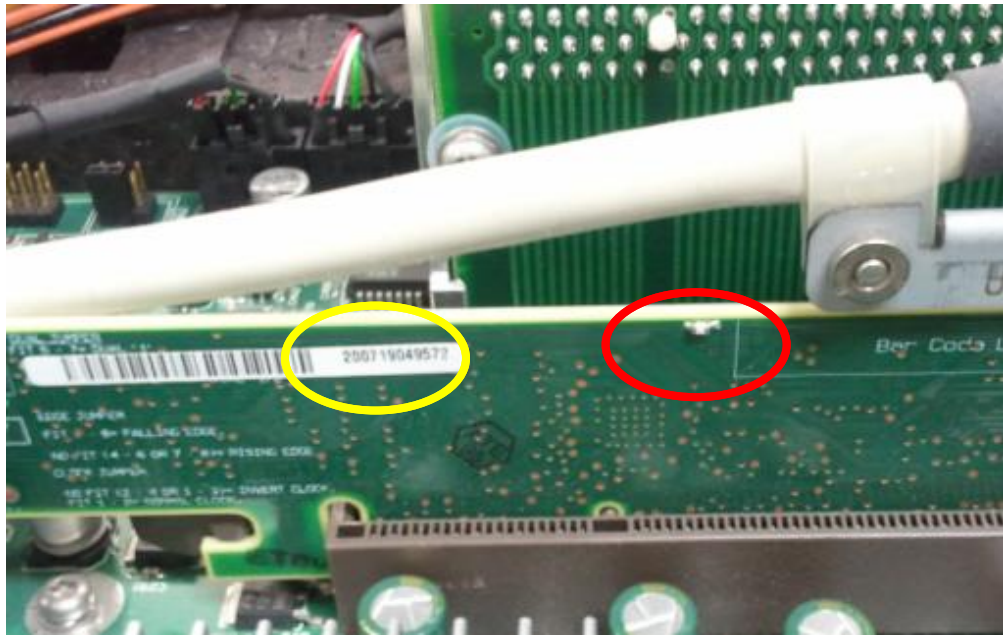
- Sample #1 (Revision NM2501):

The board has a fuse on top (red circle) and a serial number (yellow circle) starting with 200... In the case above it is 200719049572)

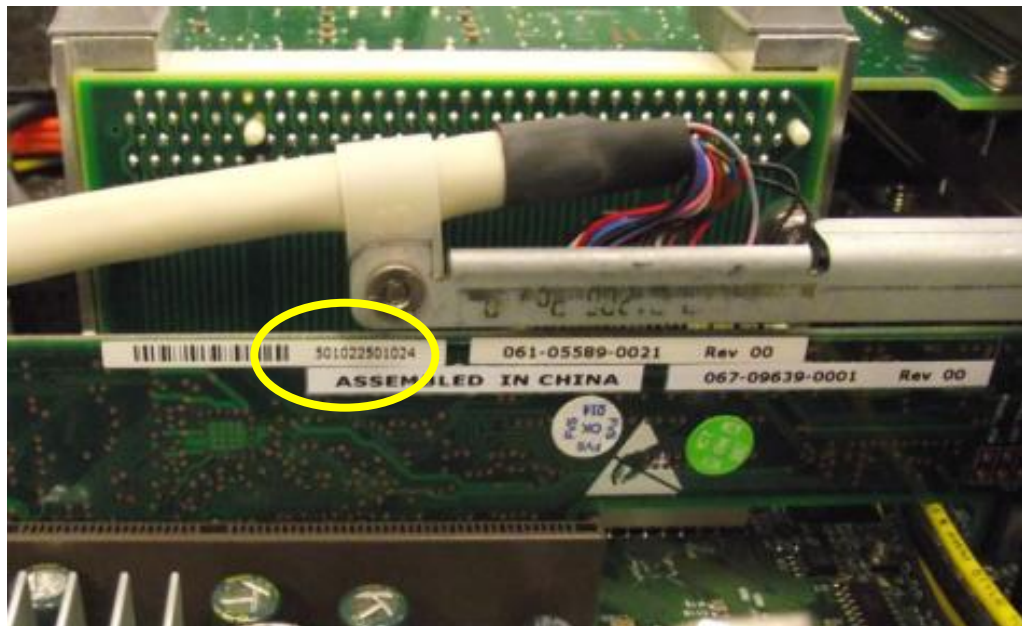
- Sample #2 (Revision NM2502):

The board has a serial number (yellow circle) **NOT** starting with 200... In the case above it is: 501022501024.

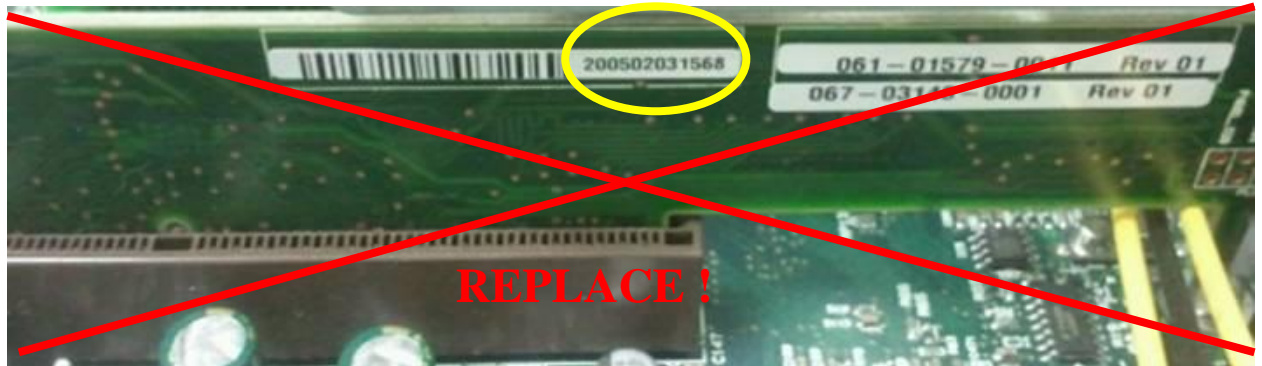
If the graphic board

shows a serial number starting with 200... AND no fuse is visible

it is potentially **hazardous** and the **unit must be set out of operation** until the graphic board is replaced (part number: N4901-66577 or N4901-69577). The graphic board can be exchanged without impacting the instrument's performance.
