N4906B-01A-S

SERVICE NOTE

N4906B - Serial BERT

WARNING HAZARD CLASS 3

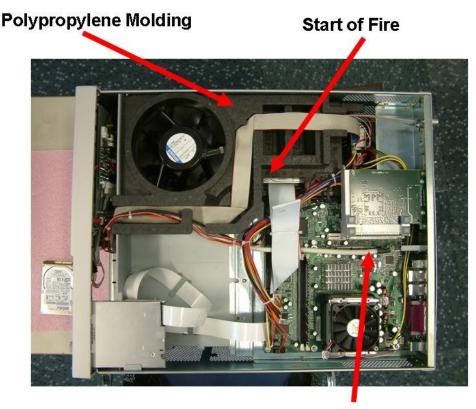
Graphics Card

A surface-mount ceramic capacitor suffered physical stress during the manufacturing process, leading the capacitor to crack. During operation this crack placed stress on the internal structure of the capacitor, and caused the plates to short together. (The plates are separated by very little space, made up of very thin insulators.) This caused the capacitor to have very low residual impedance, resulting in a very high current conducted through the capacitor and the 12V path on the motherboard for some period of time. The low impedance didn't lead to a current high enough for blowing the fuse. Therefore the higher current was available long enough to create a very high temperature ($T > 300^{\circ}C$) The high temperature ignited the polyurethane molding used to conduct the airflow for cooling through the instrument.

The following photo illustrates the layout of the instrument. If shows the polypropylene molding, the graphics card and the starting point of the fire.

The countermeasure for this issue is to exchange the graphics cards. The new graphics cards are produced with an improved manufacturing process eliminating the risk of micro cracks. They either have an additional fusing to protect the 12V path or they have eliminated the 12V path altogether. The graphics card can be exchanged by Agilent authorized personnel only.

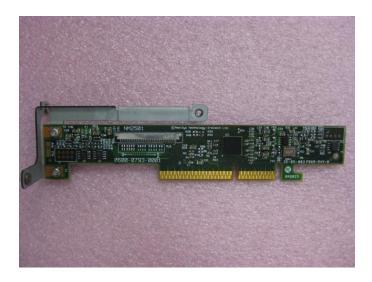
The concerned part is the graphic board: N4901-66577 (exchange part: N4901-69577):

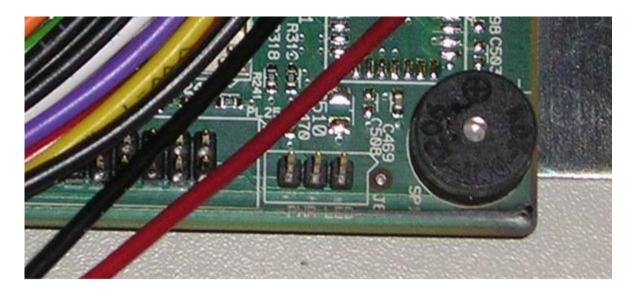
There might be discoloring on the PC motherboard in the shown corner (brown color). This can be ignored. The function or the quality of the motherboard is not affected by this.

Motherboard still considered being good – no exchange required:

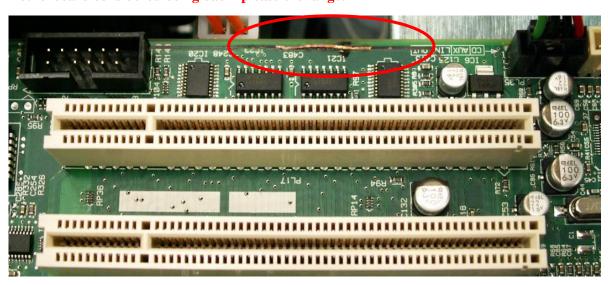
In very exceptional cases if you see traces of smoke or fire, the motherboard needs to be exchanged. In these cases typically the integrated display of the instrument would not work anymore. The exchange of the motherboards can only be done in the Service Center - onsite repair is not possible.

Motherboard considered being bad – please exchange:

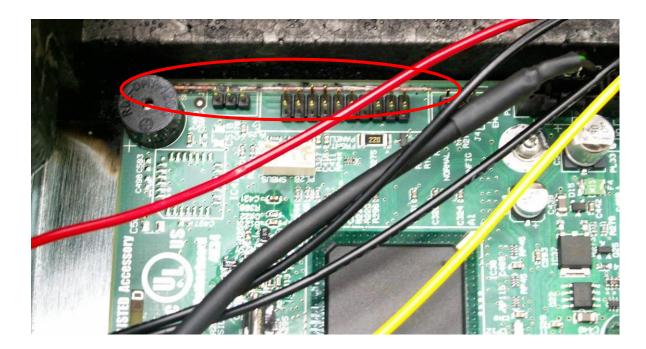
Motherboard considered being bad – please exchange:

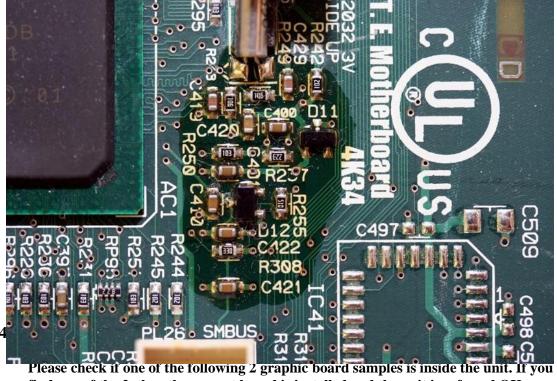
The following discoloring is intentional – no exchange required:

This effect is caused by an intentional sealing of a high impedance area to avoid issues in environments with a high degree of humidity. No exchange of the motherboard is required here.

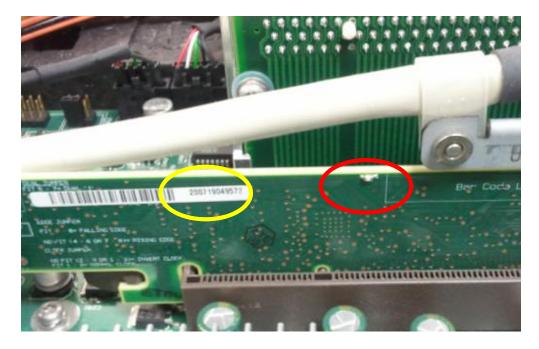
Sample #1 (Revision NM2501):

The board has a fuse on top (red circle) and a serial number (yellow circle) starting with 200... In the case above it is 200719049572)

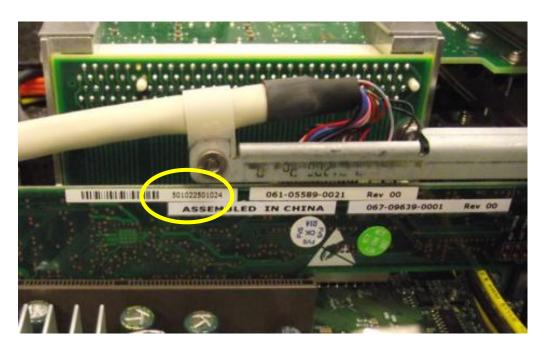
o Sample #2 (Revision NM2502):

The board has a serial number (yellow circle) ${\bf NOT}$ starting with 200... In the case above it is: 501022501024.

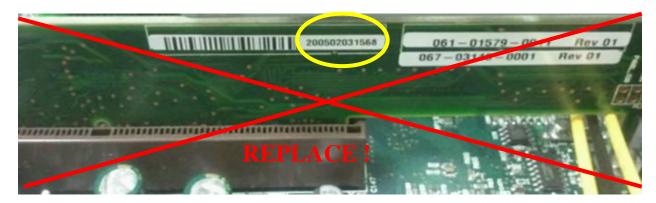
shows a serial number starting with 200... AND no fuse is visible

it is potentially **hazardous** and the **unit must be set out of operation** until the graphic board is replaced (part number: N4901-66577 or N4901-69577). The graphic board can be exchanged without impacting the instrument's performance.
