## N4962A-01

# S E R V I C E N O T E

## N4962A Serial BERT 12.5 Gb/s

Several N4962A bit error rate testers were shipped/repared with an incorrect firmware version.

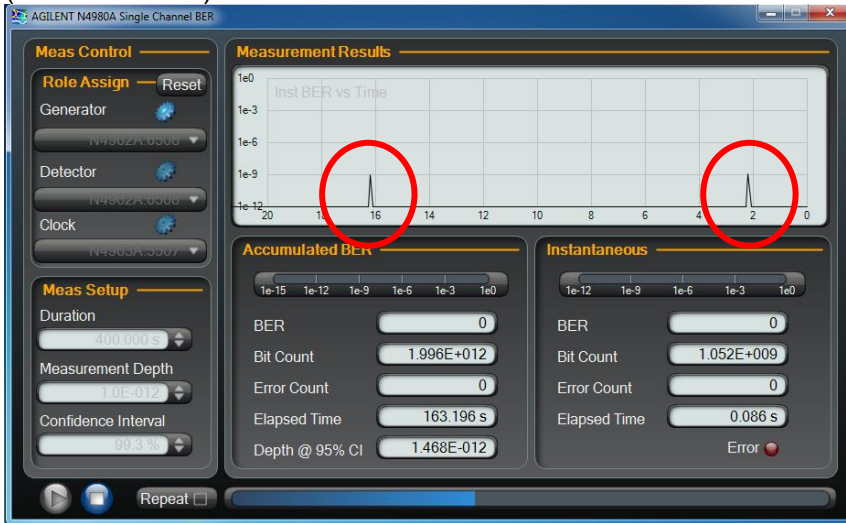
Some N4962A 10G BERT's have been reported to periodically (several times a minute) return an incorrect value when queried for BER results. The incorrect value can be the time stamp, bit count, or error count, and subsequent queries will return the correct values. When using the N4980A software single channel BER measurement, the output may look like this (see red circles):

The solution is to recompile and reinstall the N4962A firmware using the correct compiler version.

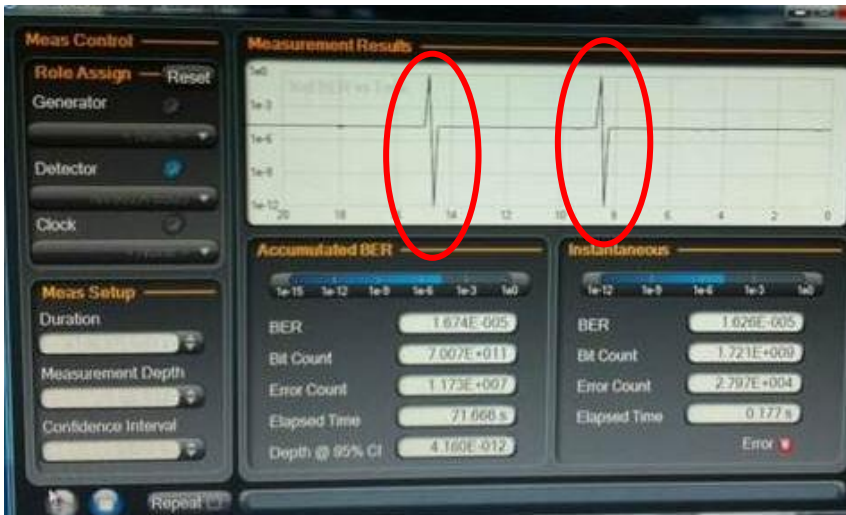
Or like this:

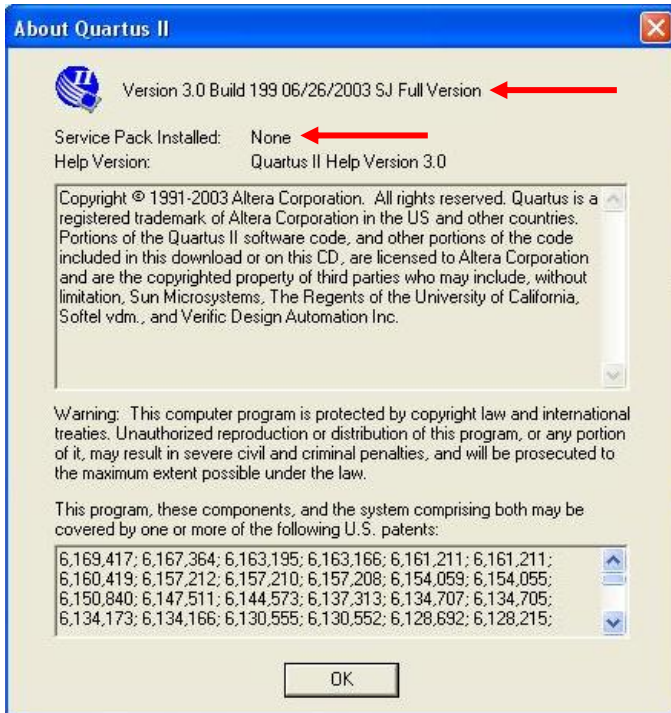
Incorrect version:

The cause of this behavior has been identified and fixed. The wrong build of firmware compiler was used for a time at the factory and was introducing this error.
