N5166B-02

Information Only Service Note

N5166B X-Series CXG Vector Signal Generator

The Problem – Self-test #104 failure if replacement A3 RF Assembly, N5180-60279 with Hardware ID 0009 is not upgraded to the minimum FW B.01.96.

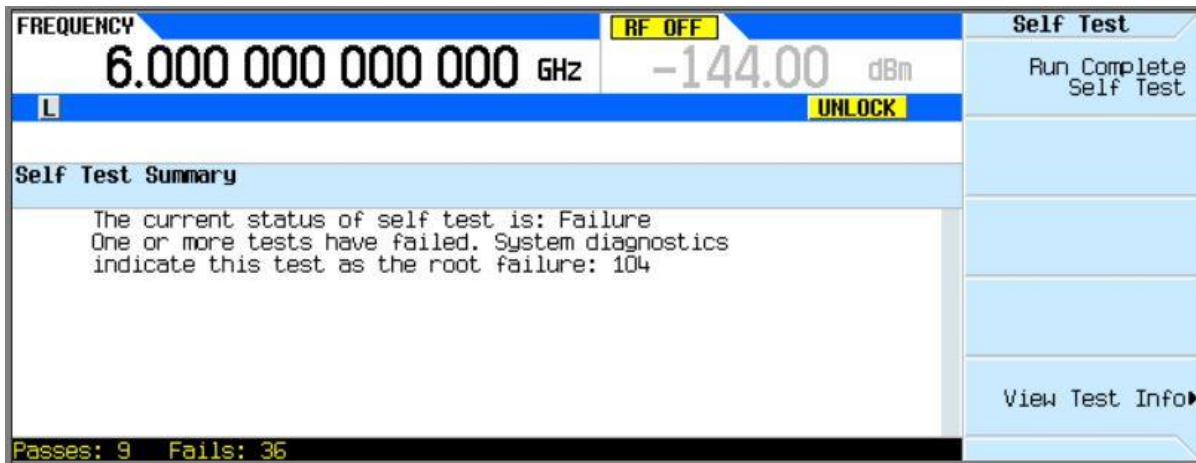
Figure 1 - Multiple self-test failures

The A3 RF assemblies were enhanced to support a new 12bit ADC for assurance of supply (AOS). Replacement of the A3 RF Assembly, N5180-60279 with Hardware ID 0009 will require minimum FW B.01.96 for it to operate properly. Multiple self-test failures can be observed after completing the self-test, as shown in Figure 1.

Upgrade the instrument firmware to B.01.96. Go to http://www.keysight.com/find/exg_firmware to download the instrument firmware.

Once the firmware successfully upgraded, verify that the self-test is passing on the instrument.

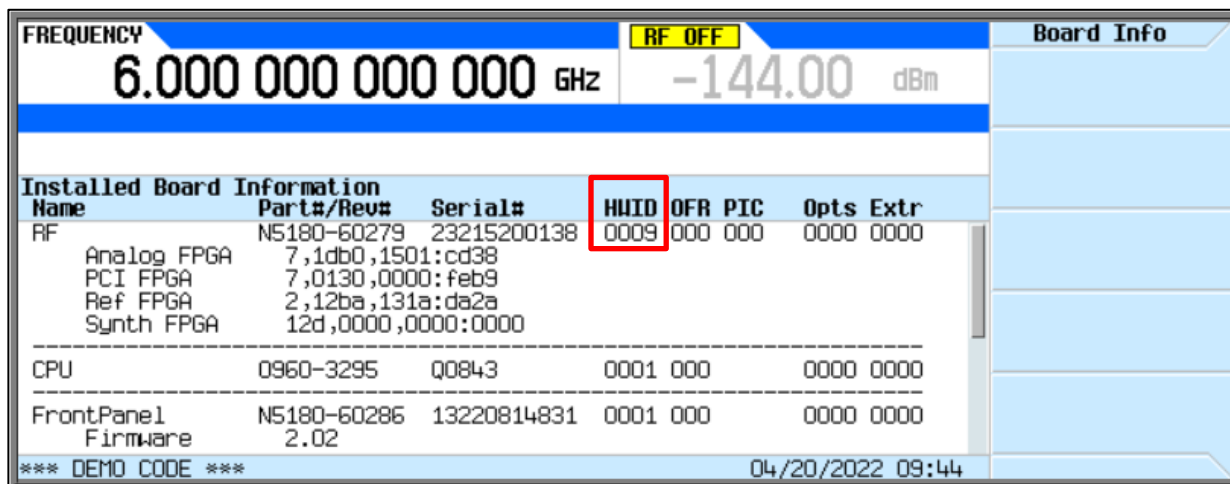
Figure 2 - Installed Board Information Screen

First, check that the RF assembly is with hardware ID 0009. This can be found on the Utility, Instrument Info, Installed Board Info screen of the instrument, as shown in Figure 2.

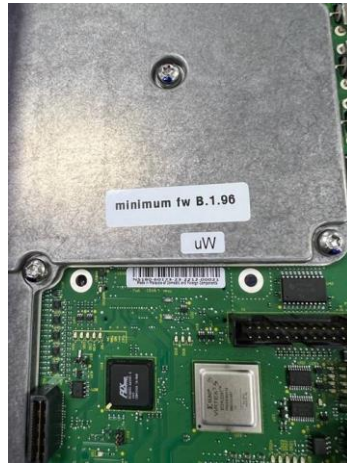
Figure 3 – Location of label on the RF assembly

Factory has also made an identification, where a label “minimum FW B.1.96” is pasted on the shield, as shown in Figure 3.
