# Information Only Service Note

# N5166B X-Series CXG Vector Signal Generator

The Problem - A3 RF assembly boards showing Heater and Unlock errors

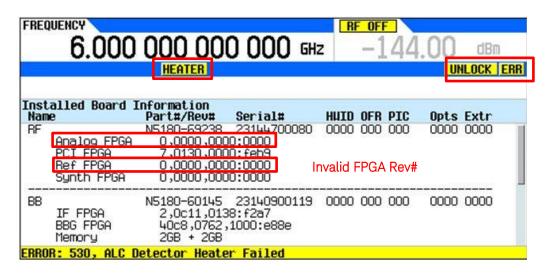
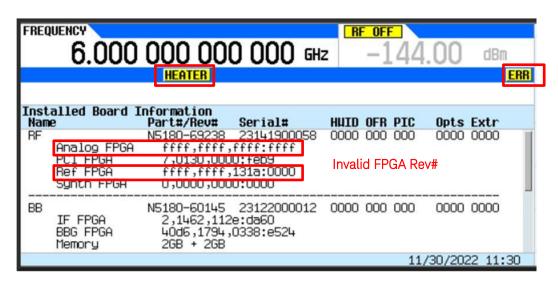
Figure 1a - Heater and Unlock Errors with Invalid FPGA Rev #

Recently we noticed several A3 RF Assemblies return to factory with the following Heater and Unlock errors at the Annunciators area. It can also include errors 619, FPGA revision is invalid. Do refer to Figure 1a and 1b for the details.

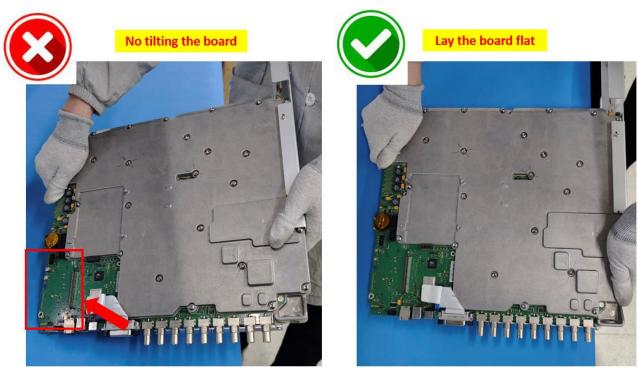
Figure 5

Avoid tilting the board where components touches the workbench. This would give pressure on the PCA and potentially can damaged the PCA as well as the components in the area. Always lay the board flat on the workbench. Refer to Figure 5.
