N5171B-06

Information Only Service Note

N5171B X-Series EXG Analog Signal Generator

The Problem – Self-test #104 failure if replacement A3 RF Assembly, N5180-60279 with Hardware ID 0009 is not upgraded to the minimum FW B.01.96.

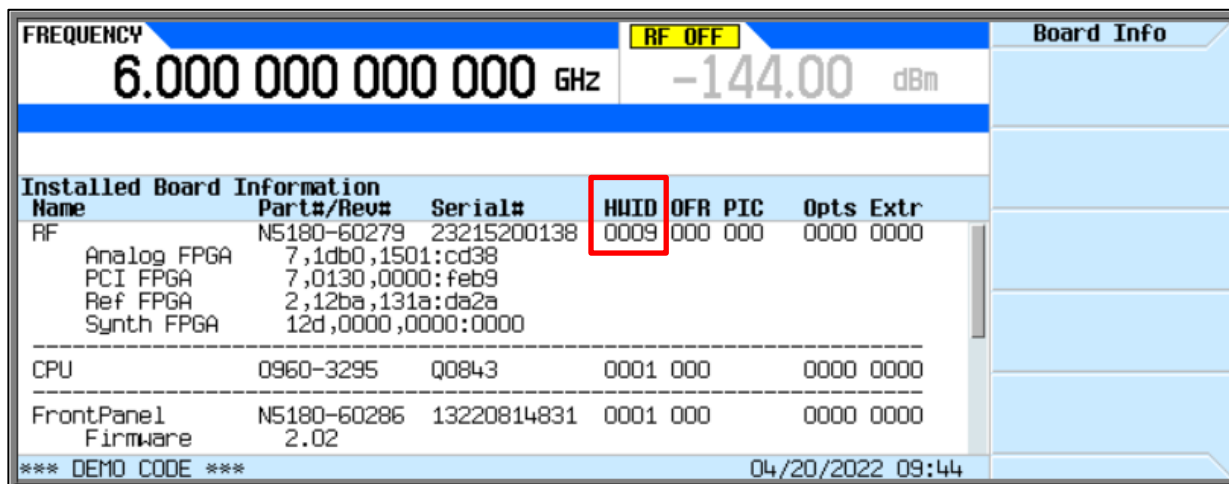
First, check that the RF assembly is with hardware ID 0009. This can be found on the Utility, Instrument Info, Installed Board Info screen of the instrument, as shown in Figure 2.

Figure 2 - Installed Board Information Screen

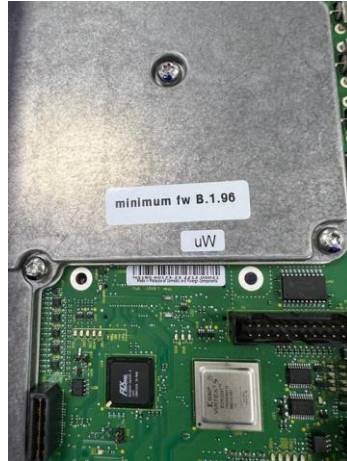
Factory has also made an identification, where a label “minimum FW B.1.96” is pasted on the shield, as shown in Figure 3.

Figure 3 – Location of label on the RF assembly
